GHAWDEX – TEMPJI TAL-ĠGANTIJA - RAPPORT

STRUCTURAL SURVEY AT GGANTIJA TEMPLES, GOZO

CONTRACT CT2115/2009

STRUCTURAL ASSESSMENT REPORT

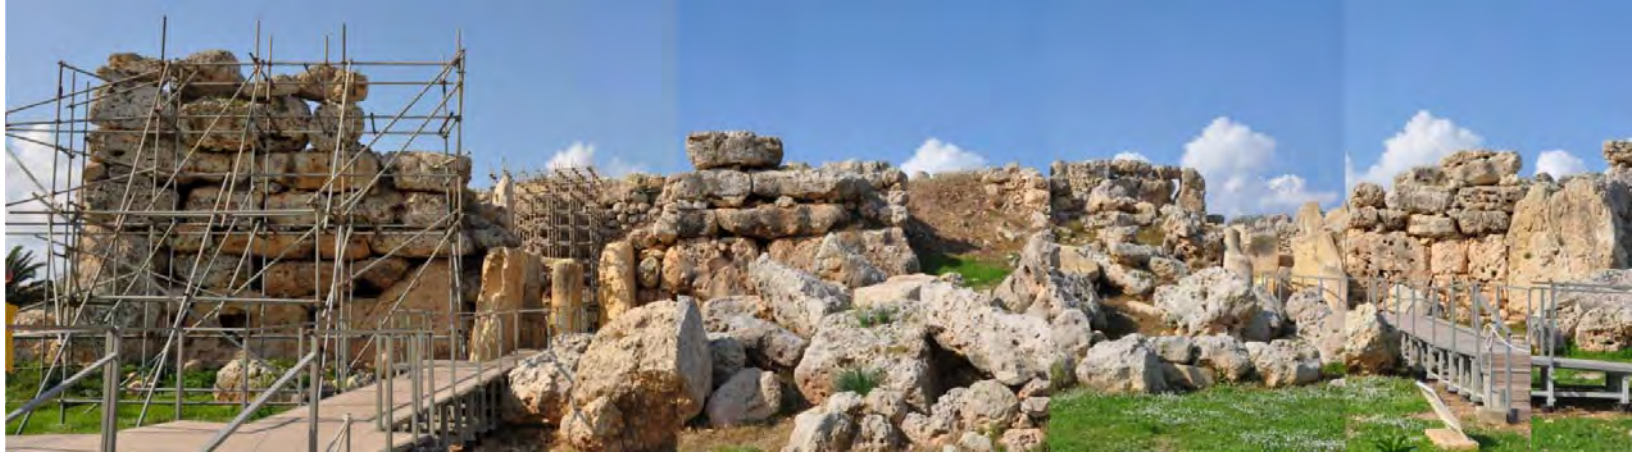
3. South-east Elevation - composite

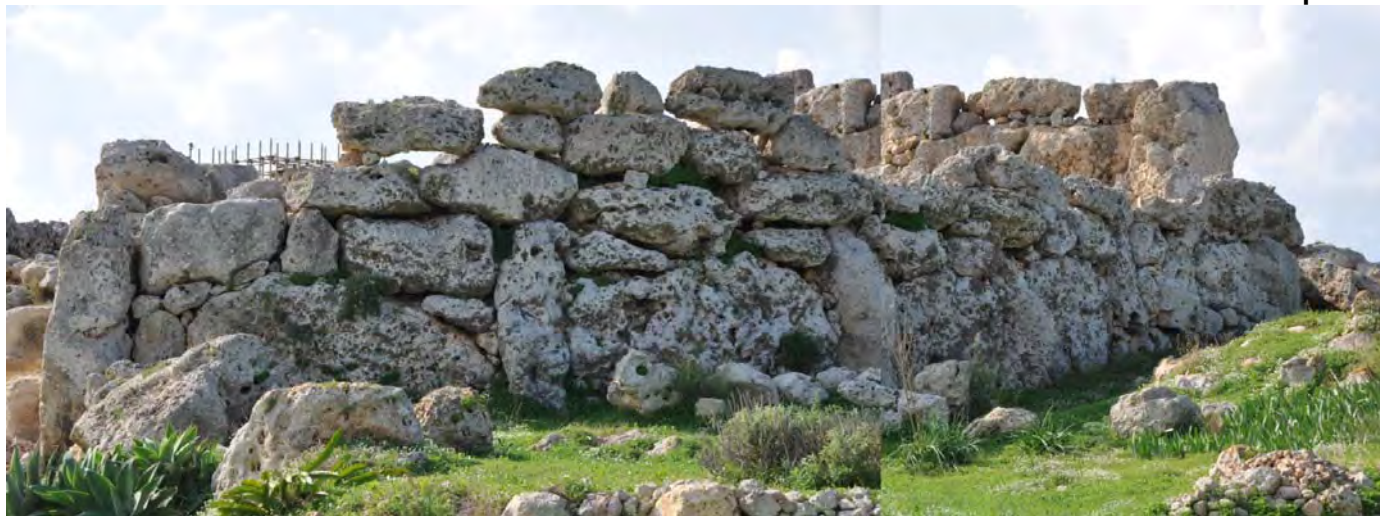
4. The North-east elevation shows the beginning of the characteristic construction system of the exterior wall, as referred to before. The horizontal courses of megaliths that are extant, are barely in contact with one another, and are particularly susceptible to displacement under actions normal to the plane of the façade.

4. North-east Elevation - composite

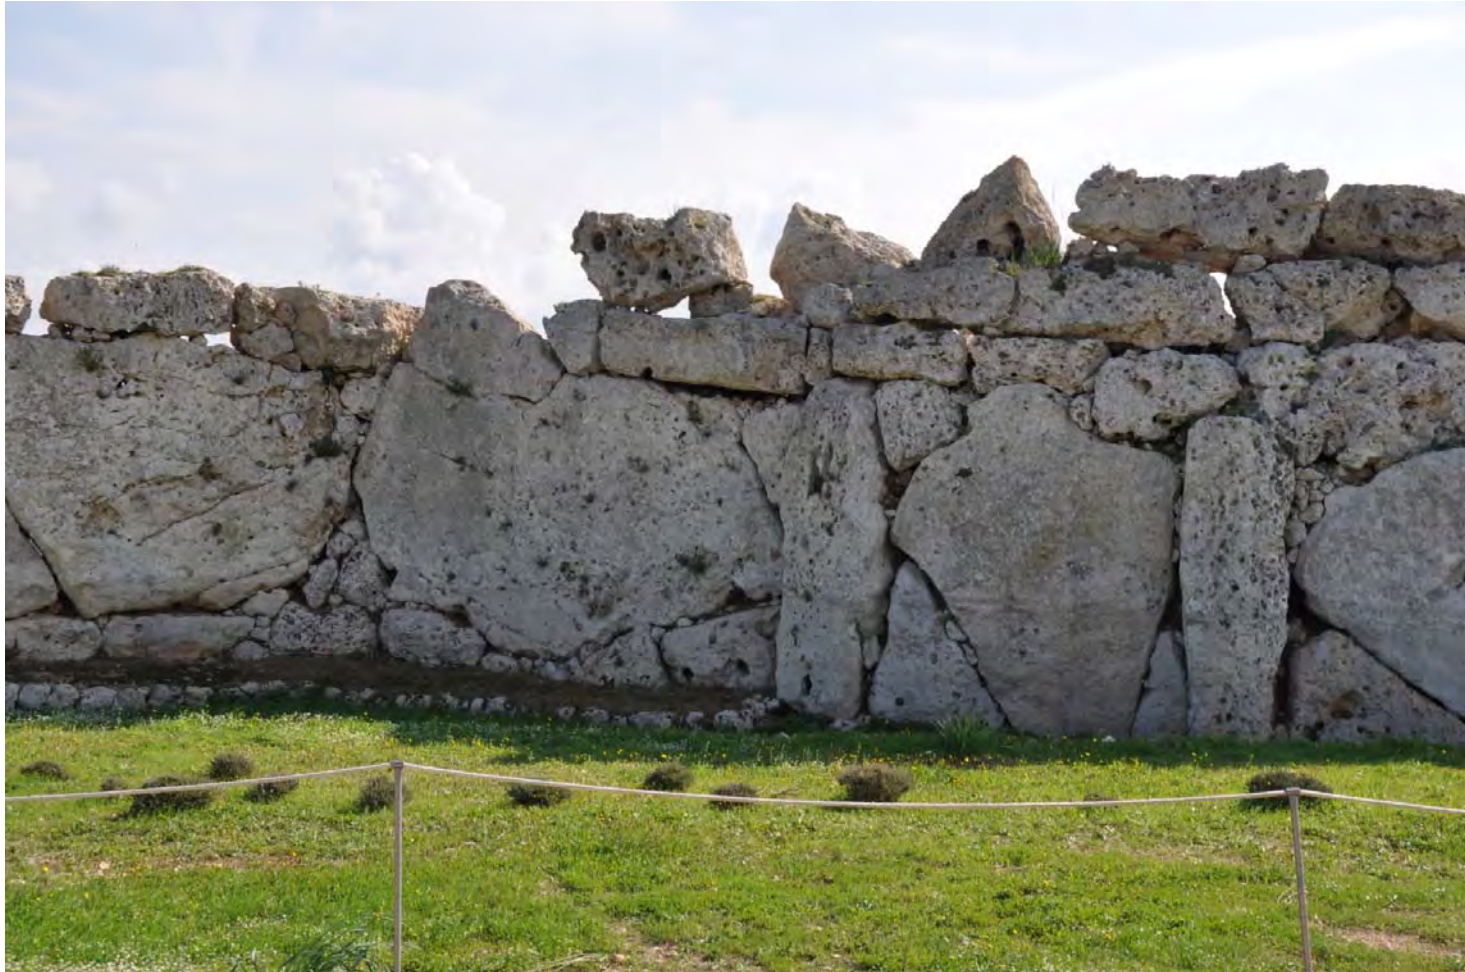
6. North-west external wall - detail

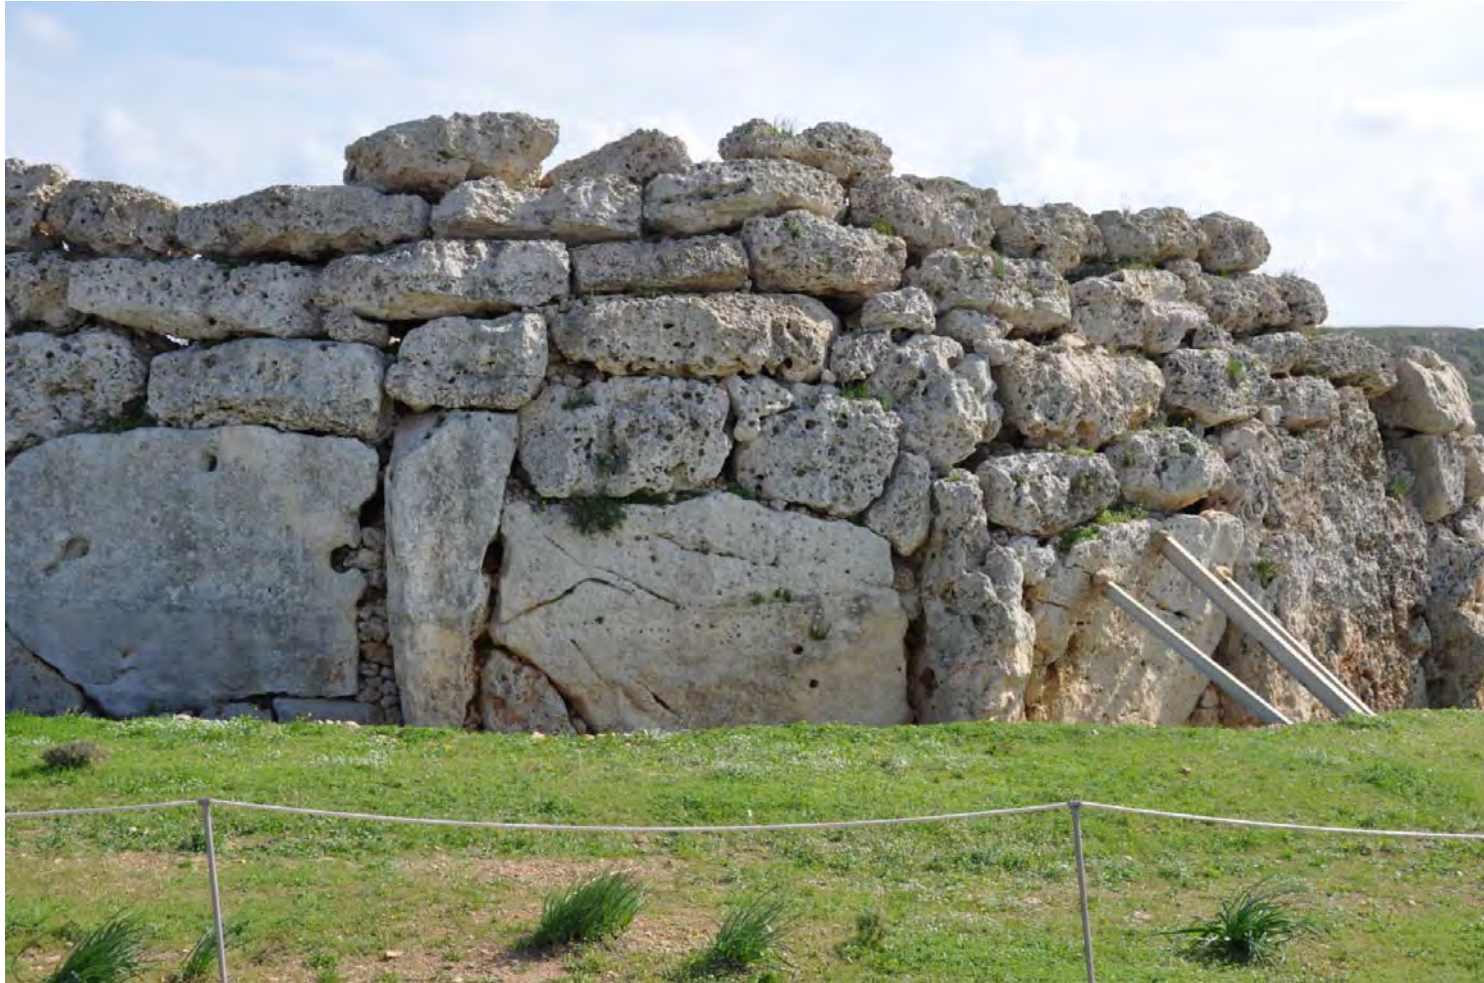
7. West external wall - detail

6. Continuation of north-west elevation detail. Same comments.
7. Continuation of north-west elevation detail. Close-up of the external props. If the external displacement of the propped megalith is continuing, and if the props are actually supporting the top part of the wall, it is possible for the megalith to fail in flexural tension along a horizontal line – the horizontal cracks which are visible could actually have been caused by this situation. On the other hand, there is no current sign of continuing distress.

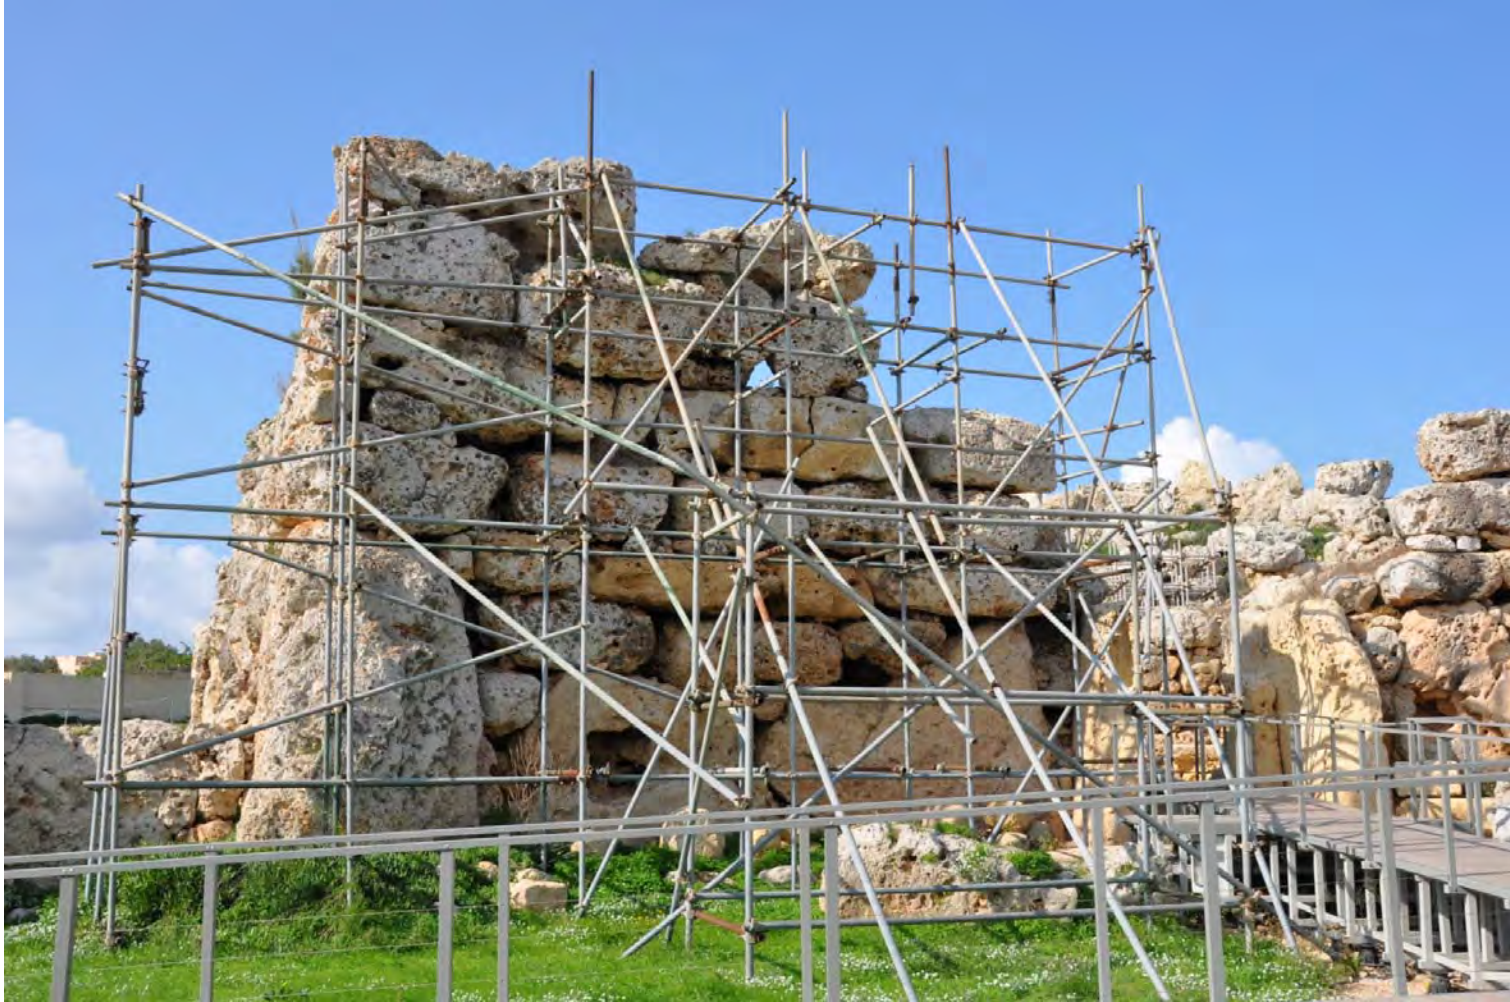
13. Propped south-east facade – detail

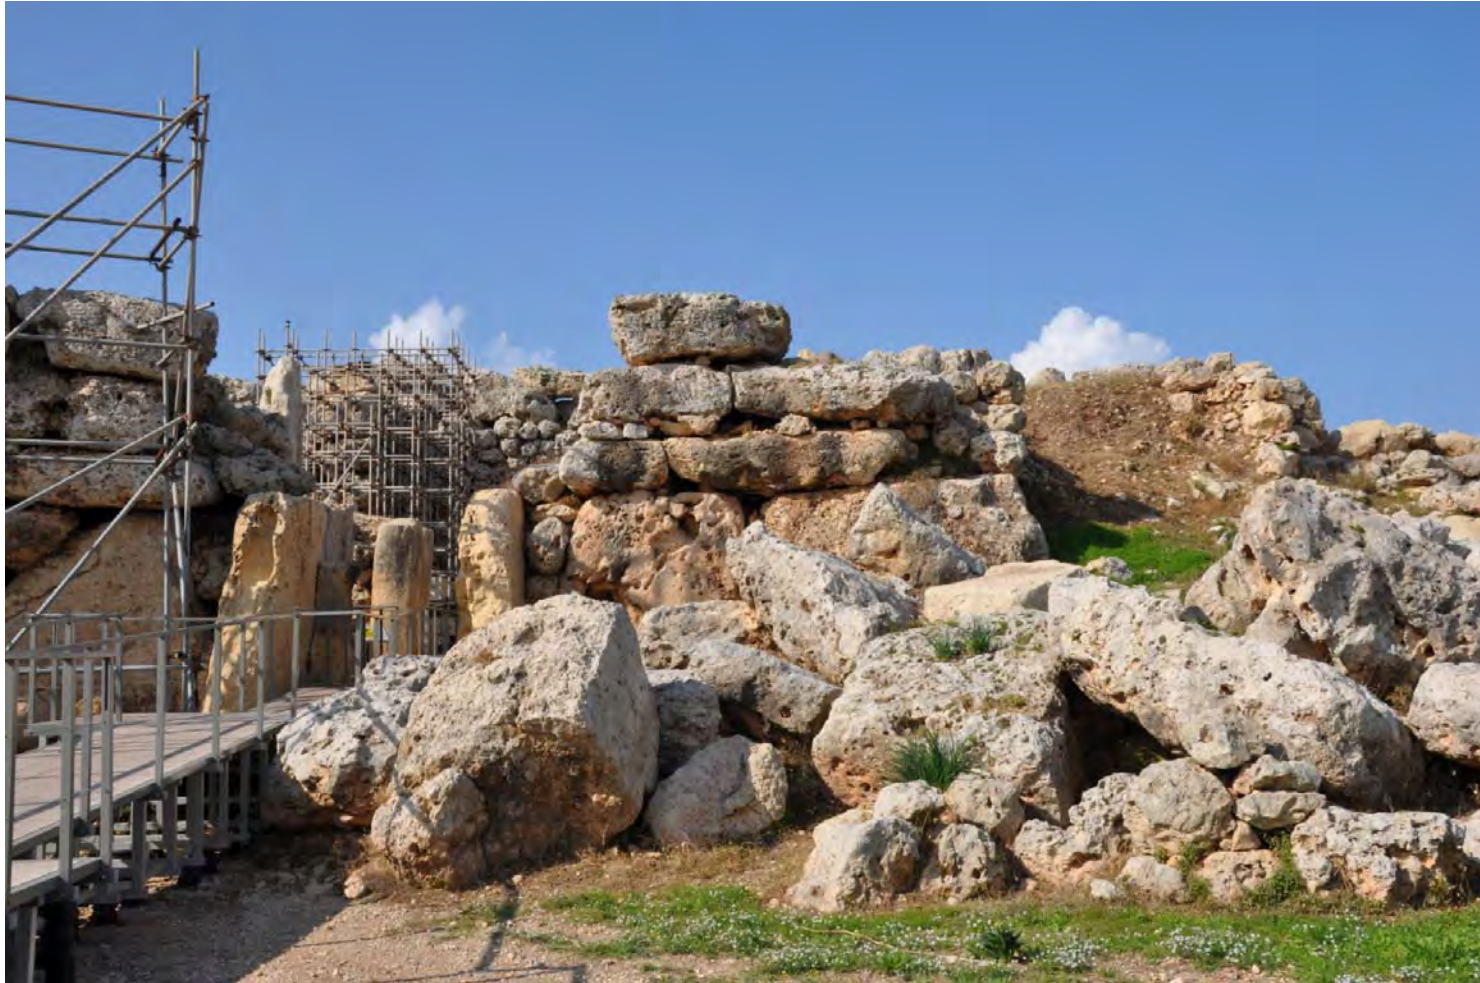
14. Previous collapse between temples – south-east facade detail

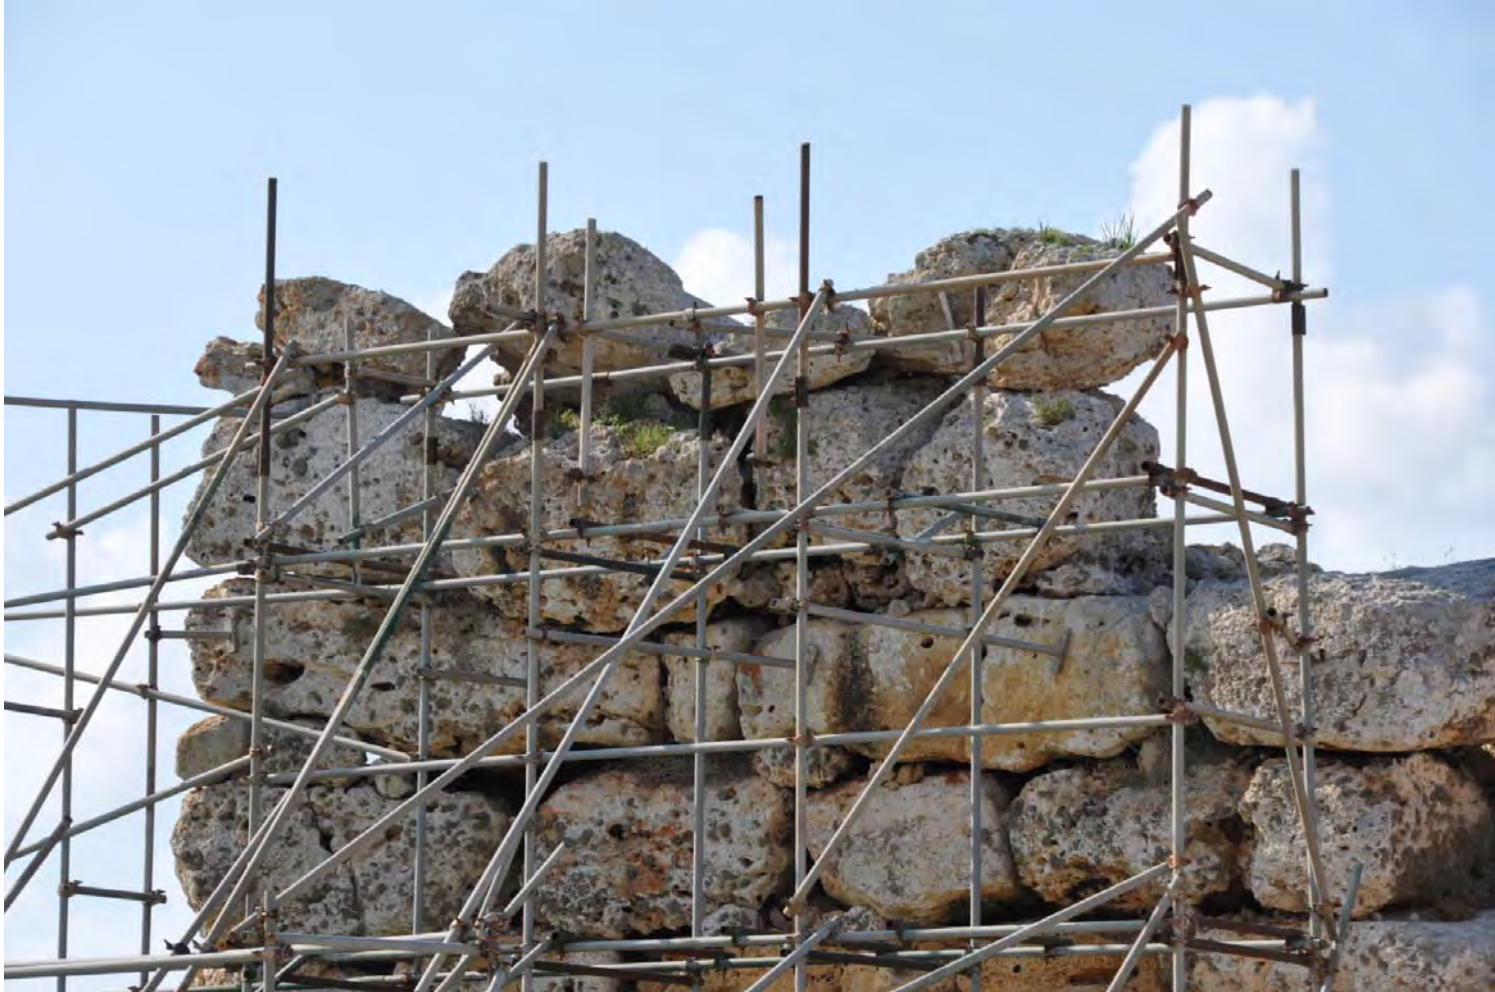
15. Propped south-east facade – close-up

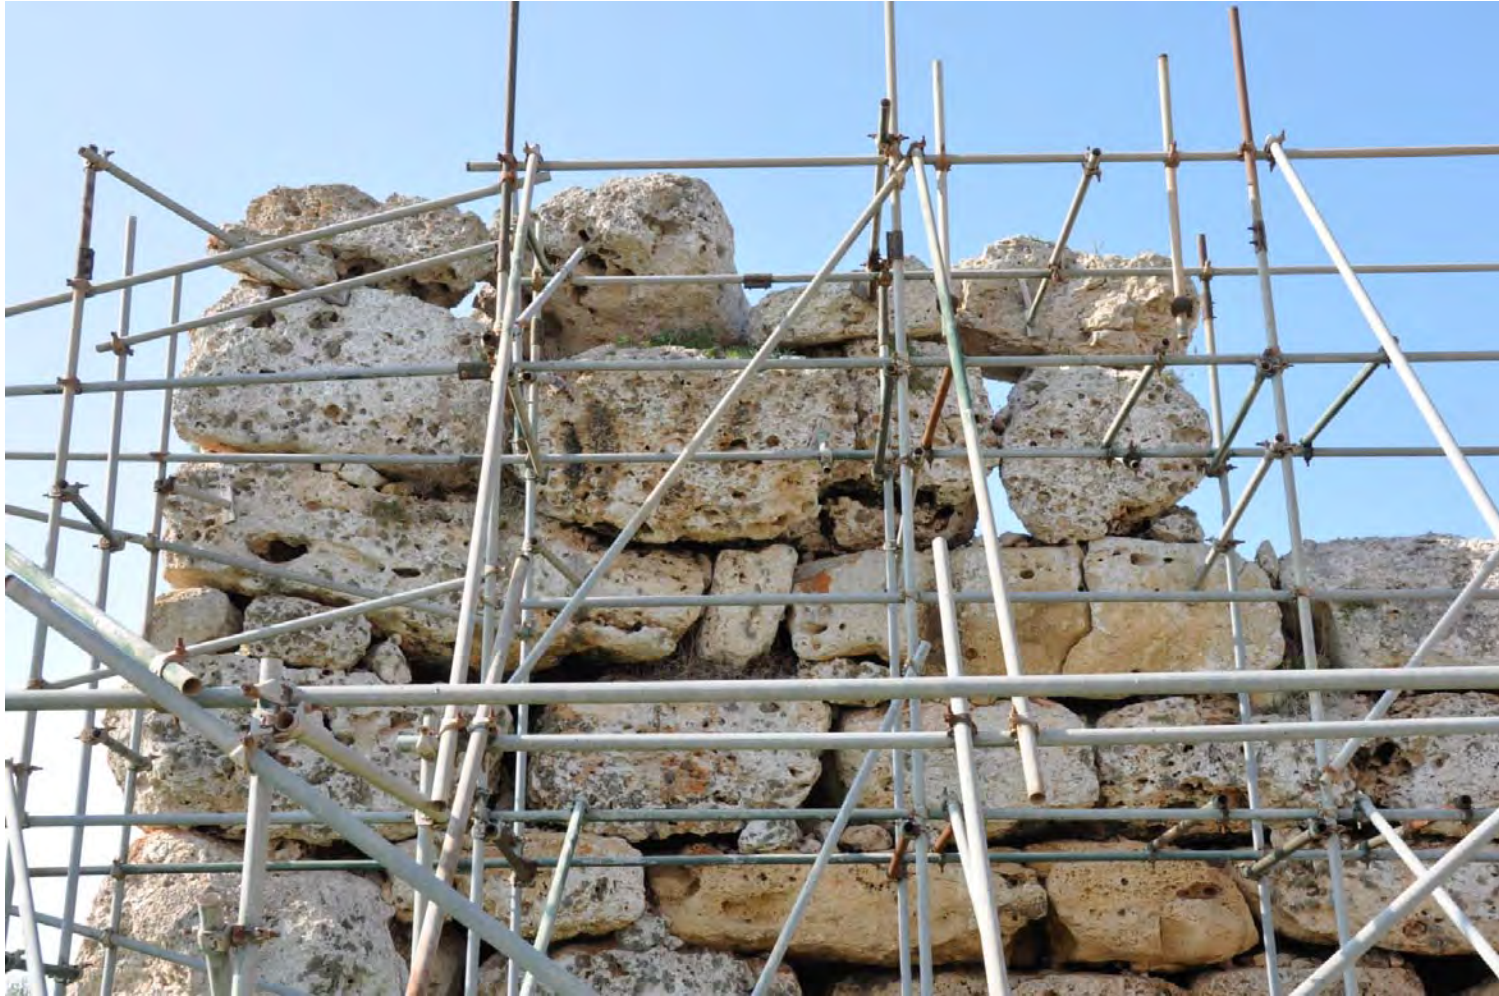
16. Propped south-east facade – close-up

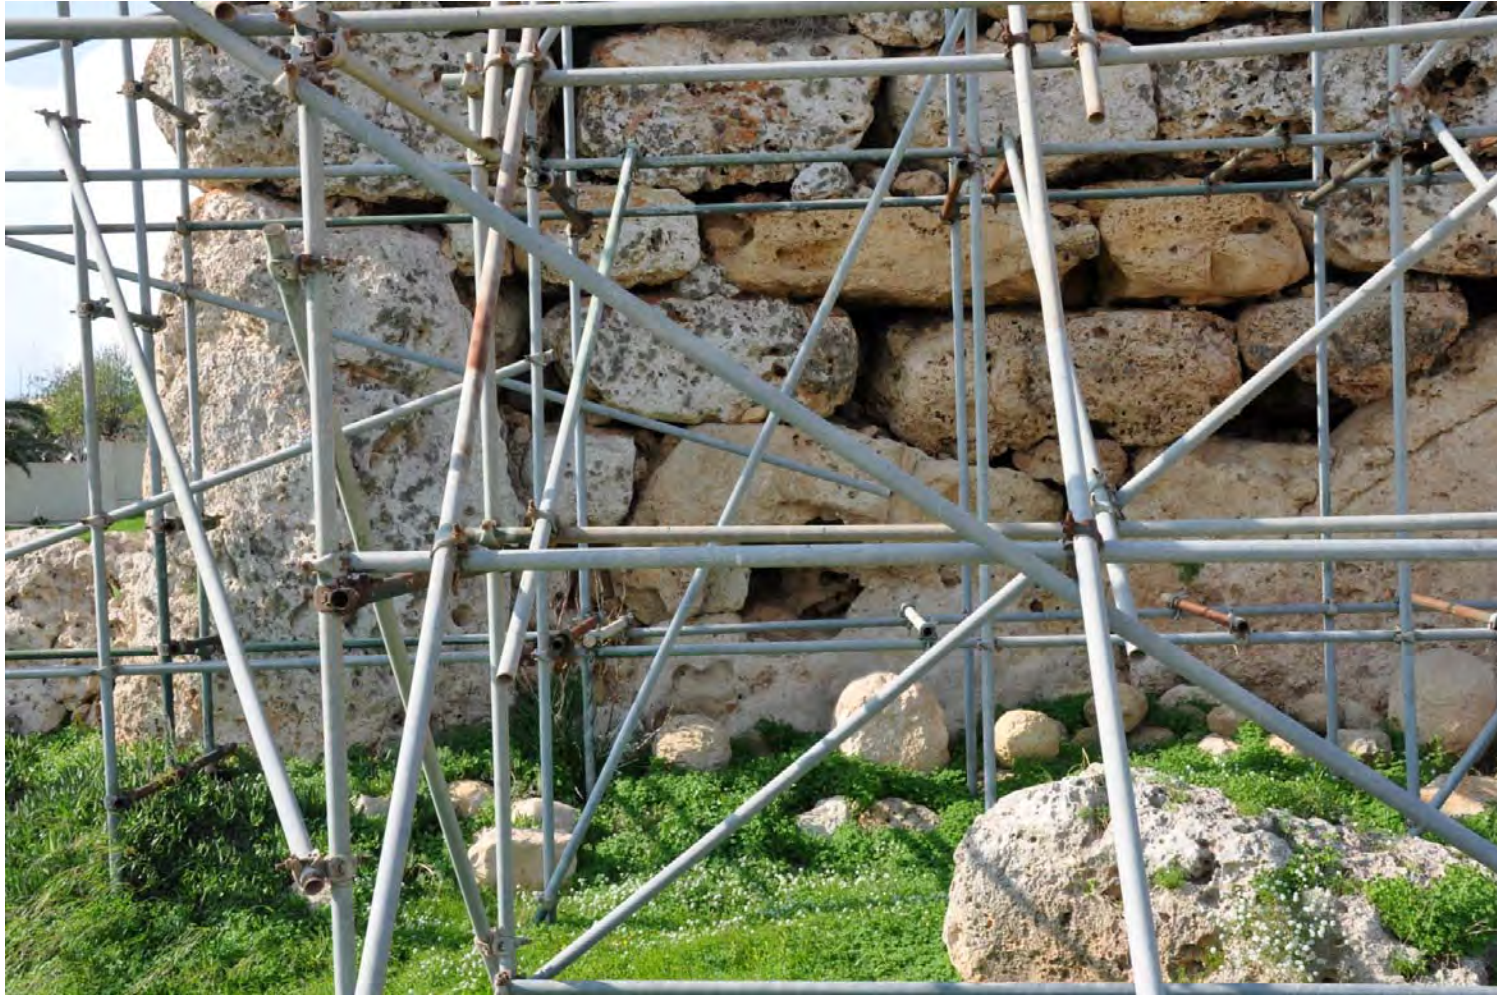
17. Propped south-east facade – close-up

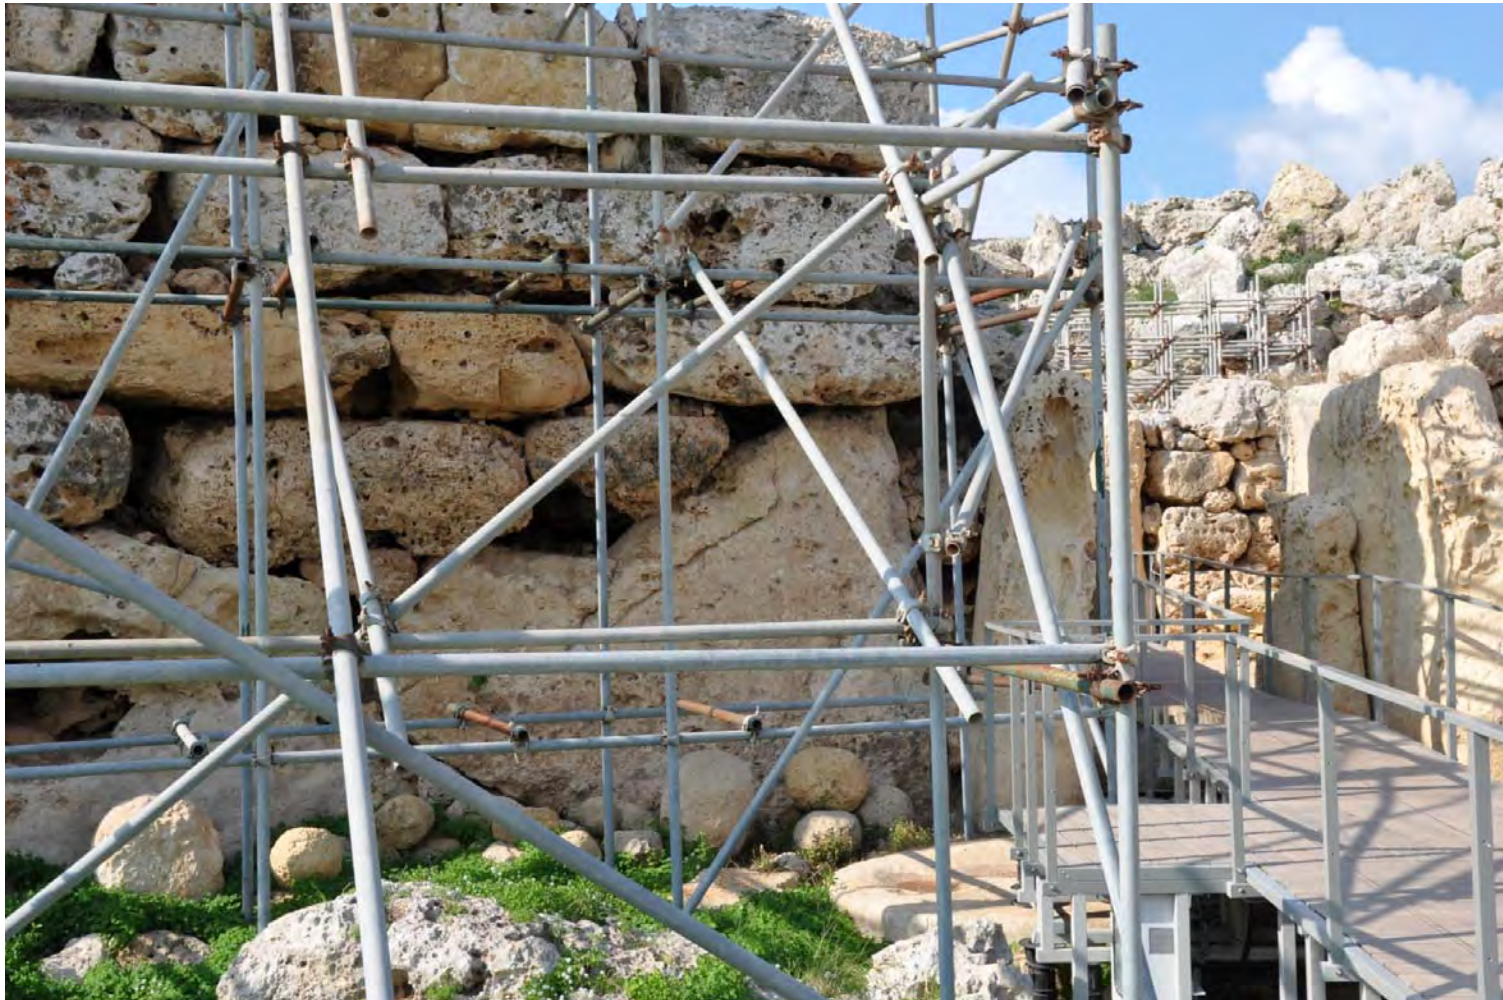
18. Propped south-east facade – close-up

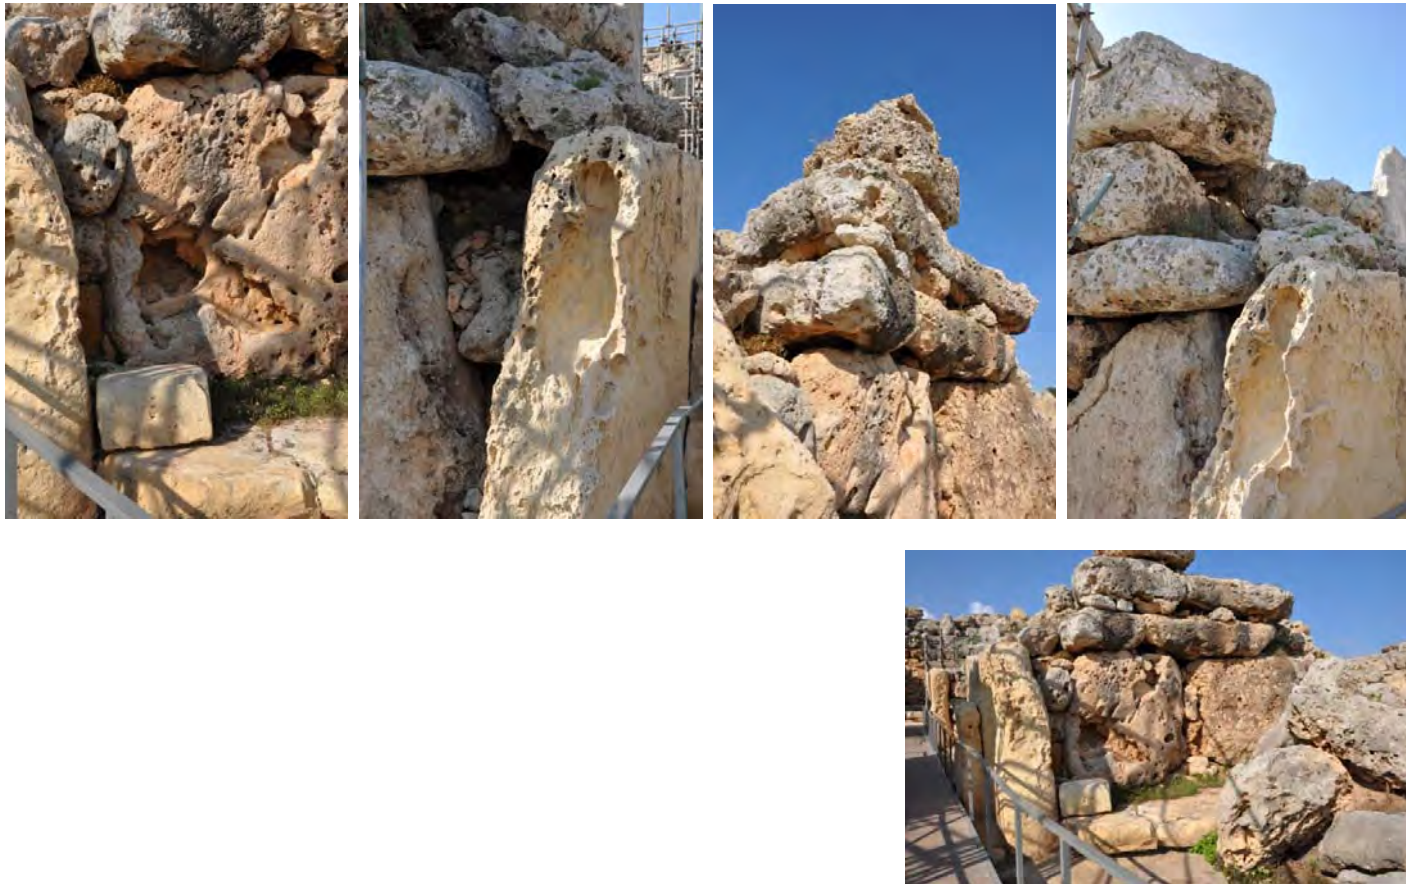
20. Erosion, cavitation and precarious equilibrium in south-east facade – close-up

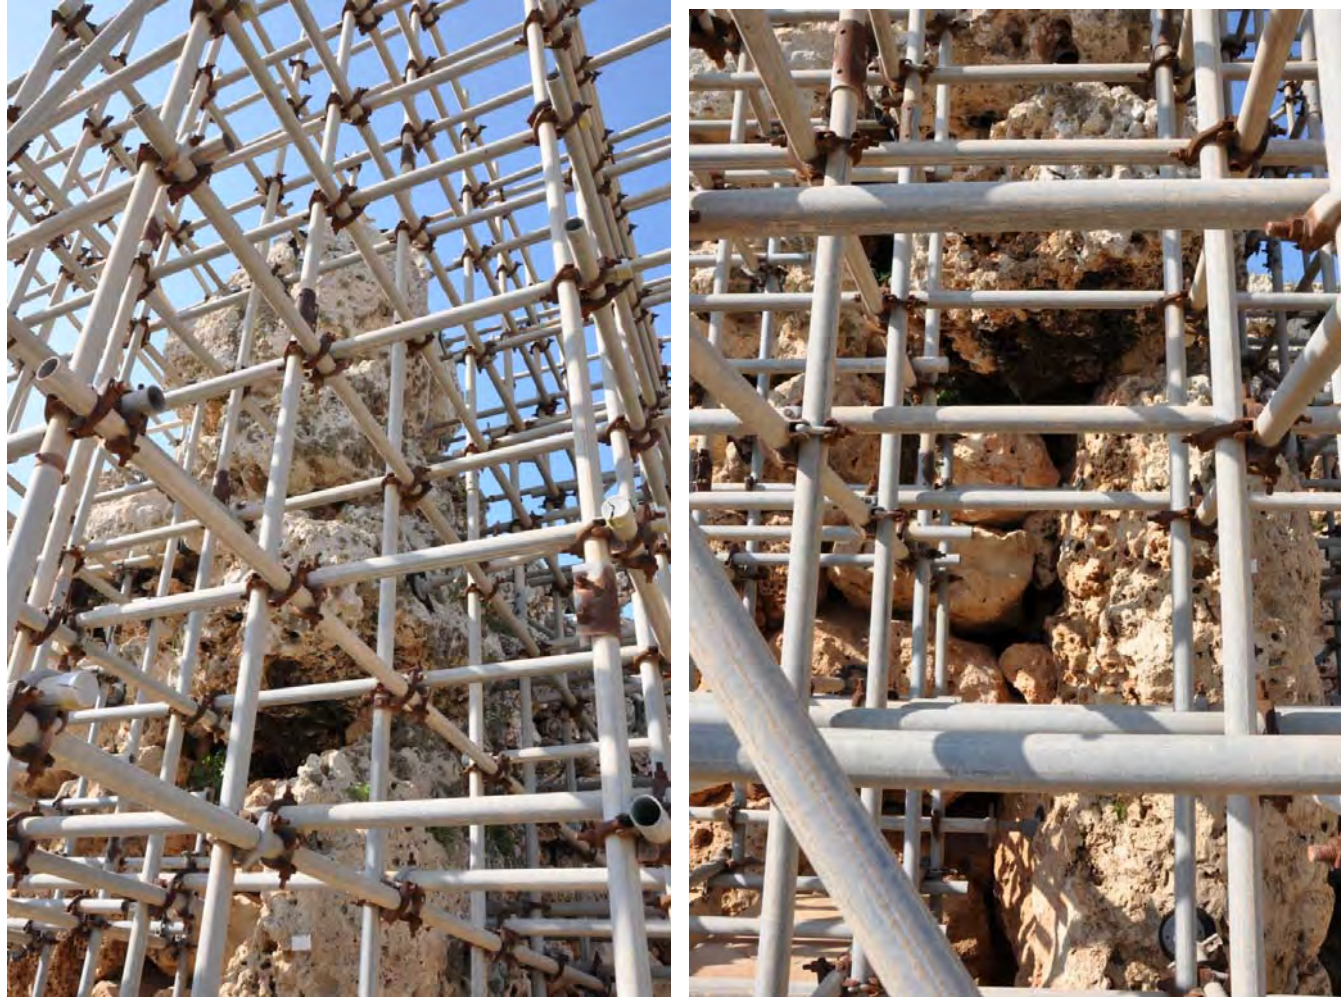
28 , 29. Detail of scaffolding – junction between apse 6 and 7 – discontinuity in masonry assembly

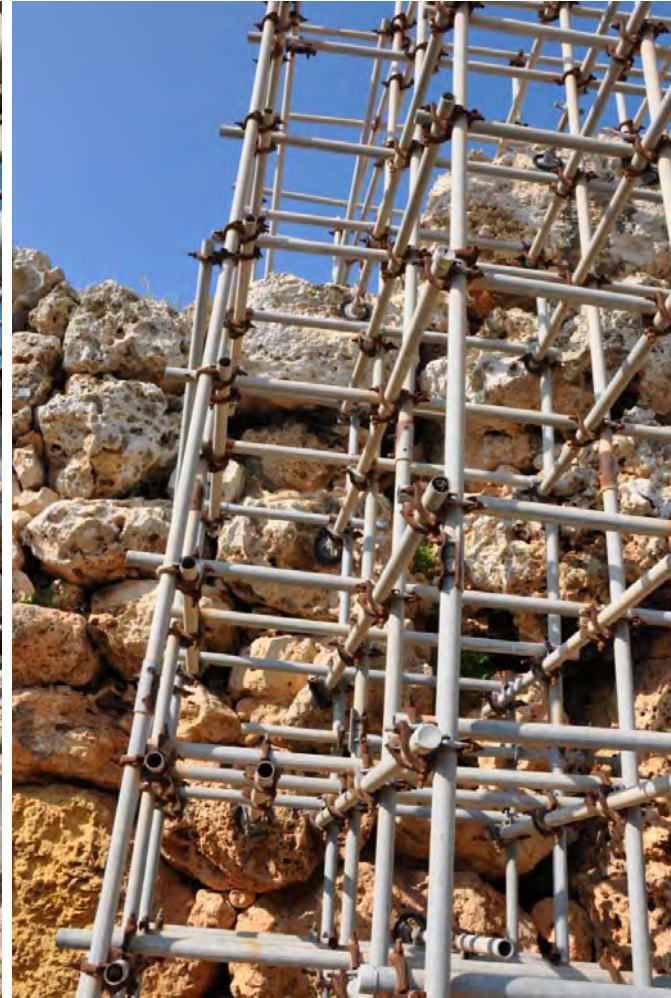
30 , 31. Detail of scaffolding – junction between apse 6 and 7 – discontinuity in masonry assembly

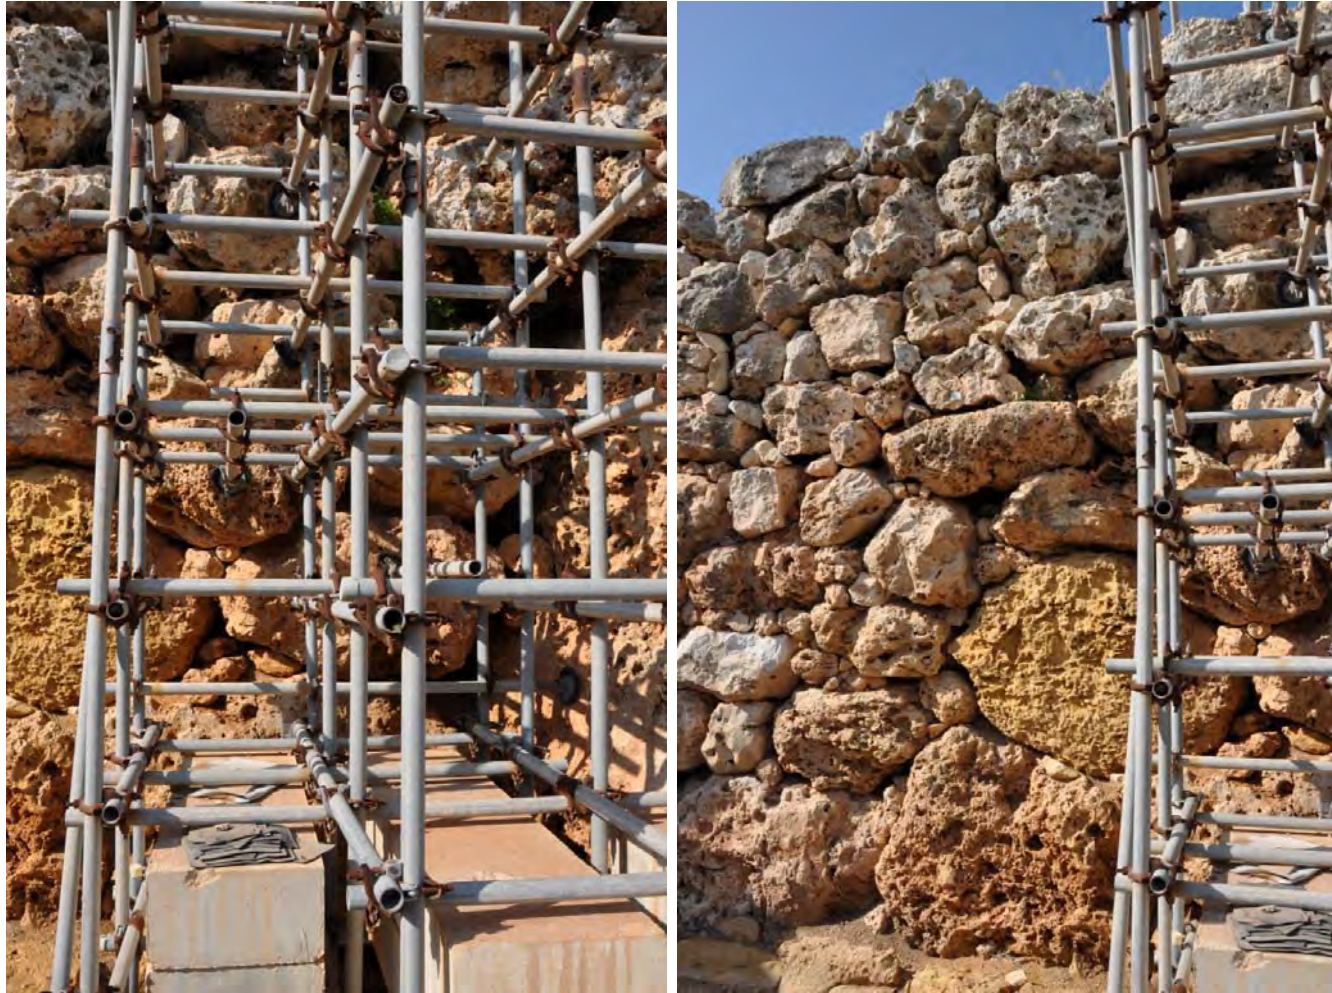
32 , 33. Detail of scaffolding – junction between apse 6 and 7 – discontinuity in masonry assembly

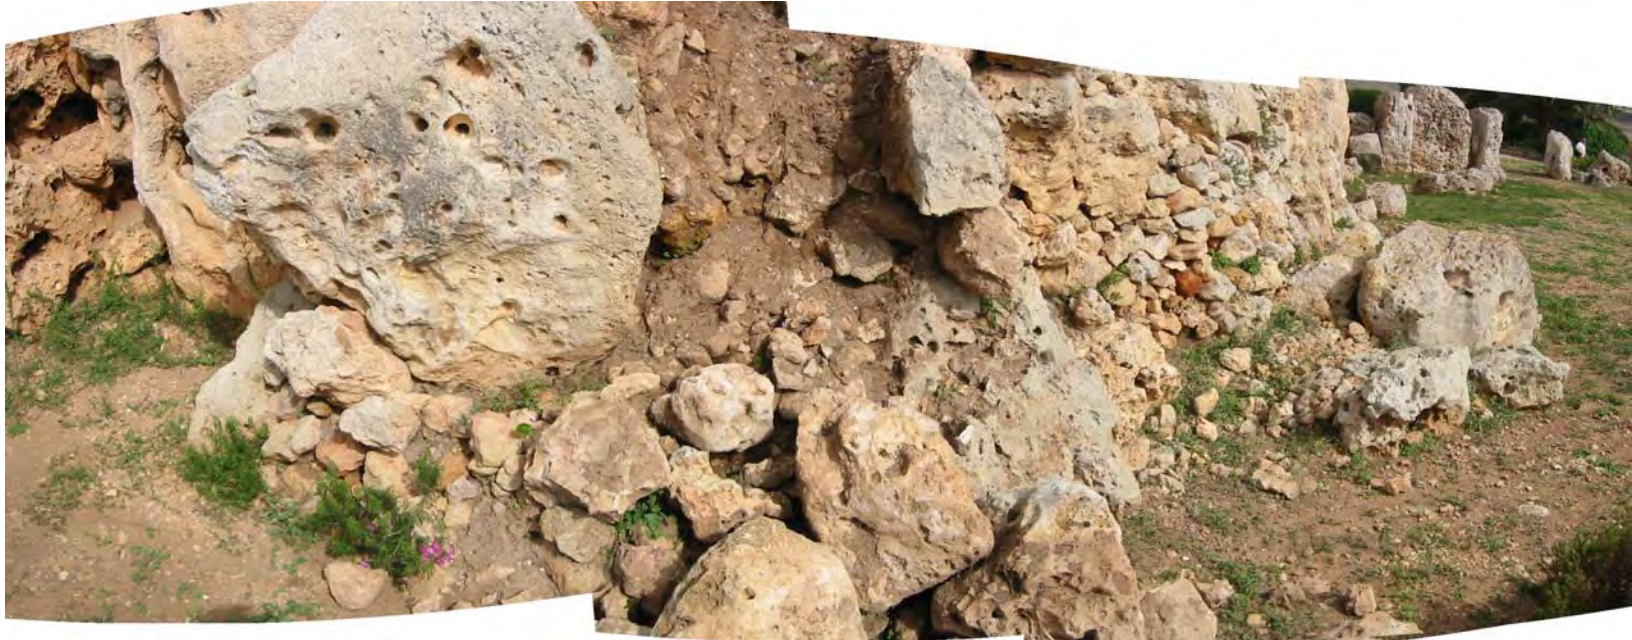
73. View of 2003 collapse in south-west elevation – composite

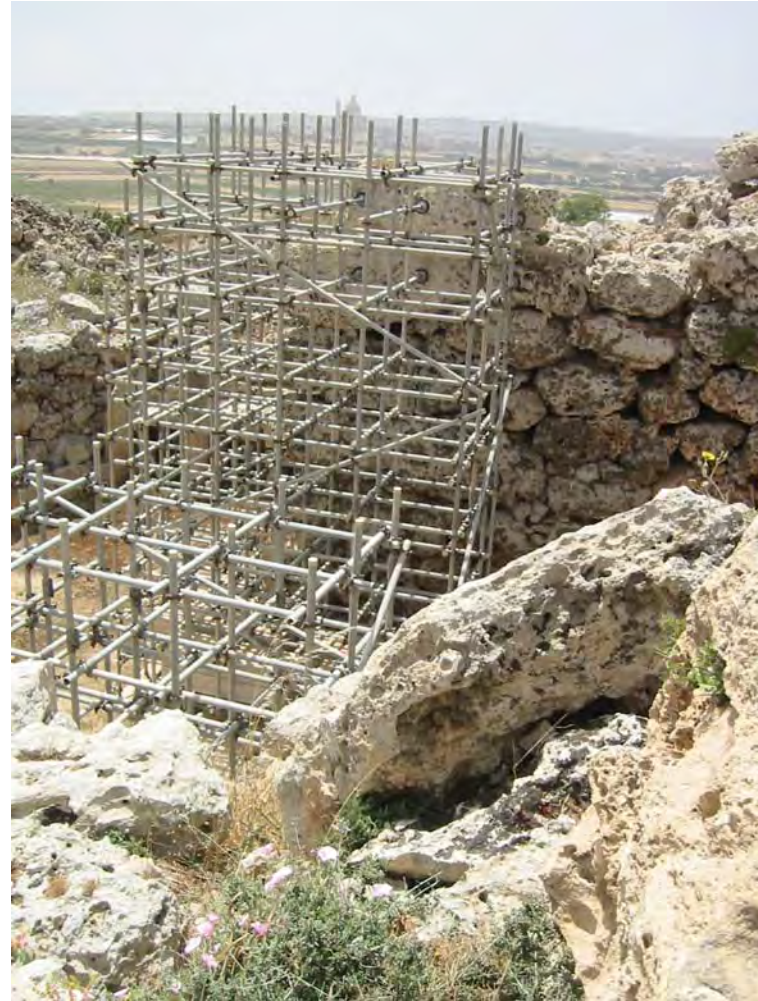
77. 2005 view of South Temple – propping at Apse 7
