**UC Limited**  
**BULK CEMENT Storage Terminal**  
*Laboratory Wharf, Kordin*

# Drawings attached to MEPA's clearance letter dated 17<sup>th</sup> October 2012

Failure Modes & Effects Analysis

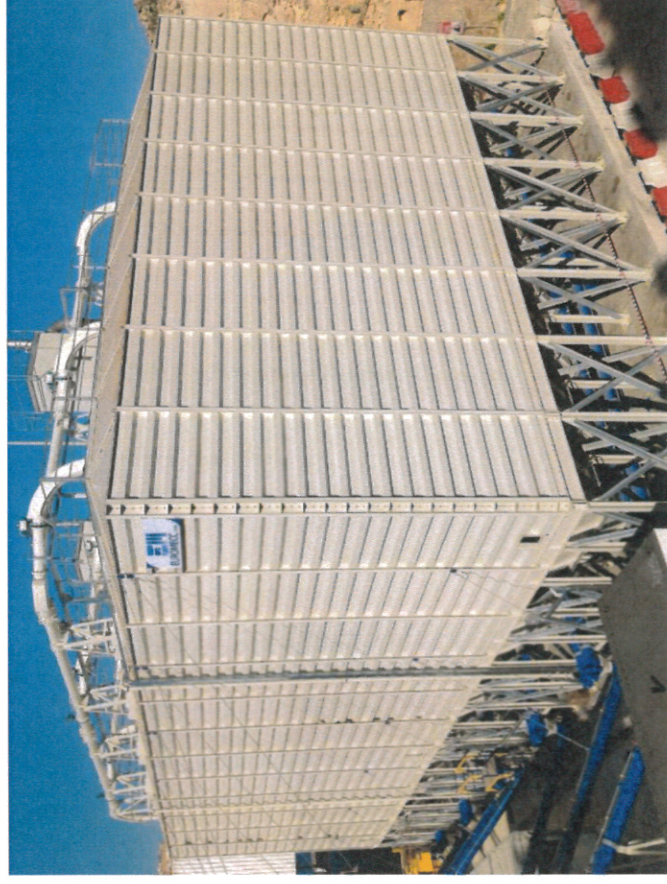
Silo Assembly and testing was  
completed in January 2014

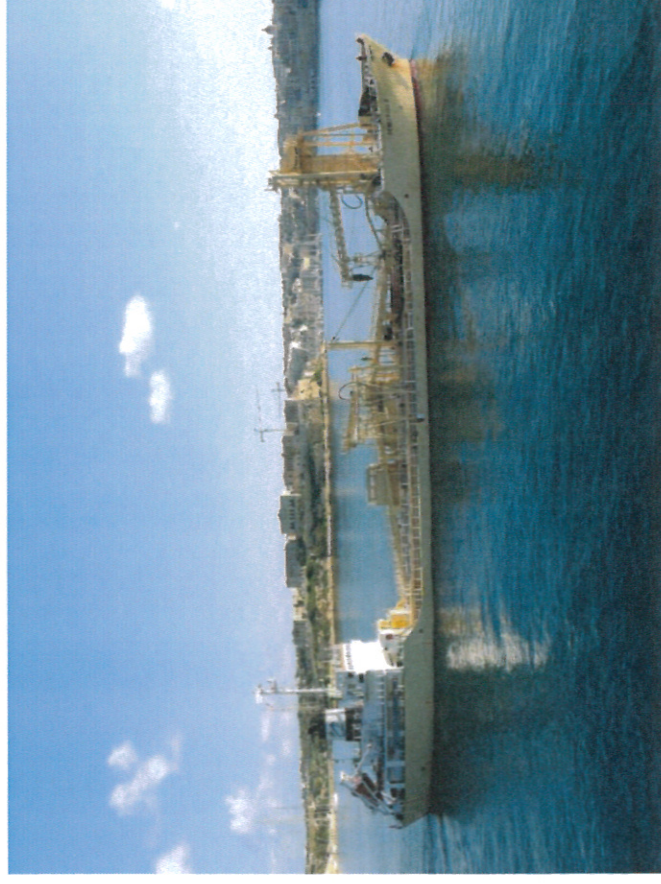
The first cement consignment  
arrived in Malta on January 15<sup>th</sup>  
2014

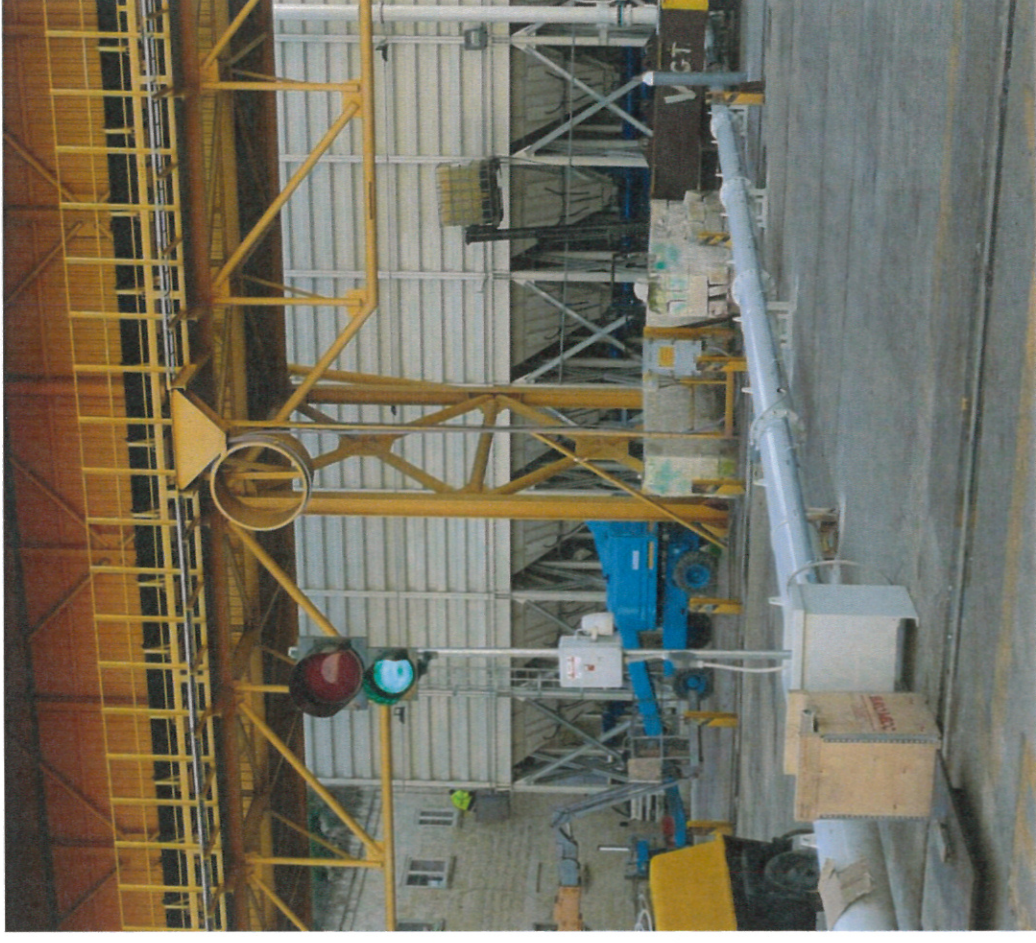
# Under/above ground Ship discharging pipe

- Steel pipe crossing the quay and connecting the cement bulk carrier to the silos.
- 300mm in diameter and composed of different sections connected together with DN300 PN10 flanges.
- Gaskets placed in between flanges.
- Section of pipeline located in the vehicle route is placed underground within a fully accessible culvert.

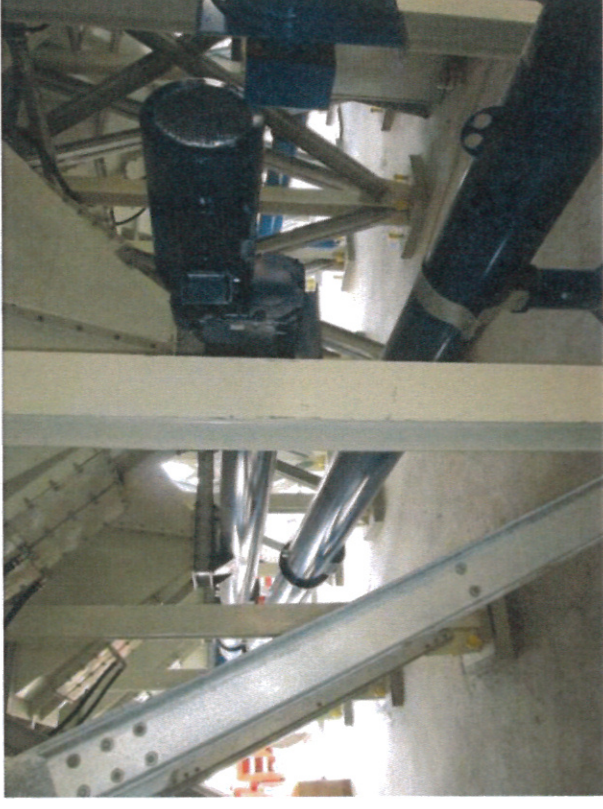
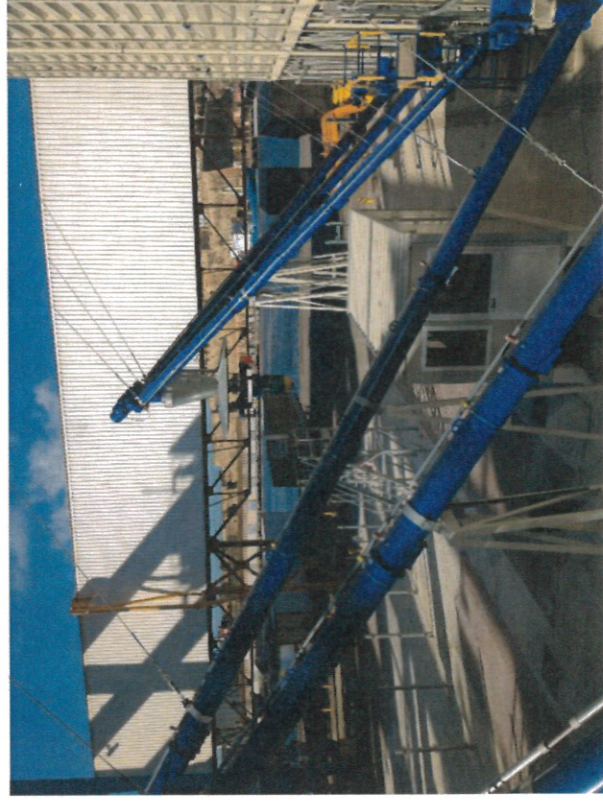
# Silo Discharging Pipes (screw conveyors)

- Totally enclosed screw conveyors.
- Screw conveyors connected together with flanges with gaskets placed in between to prevent leaks.

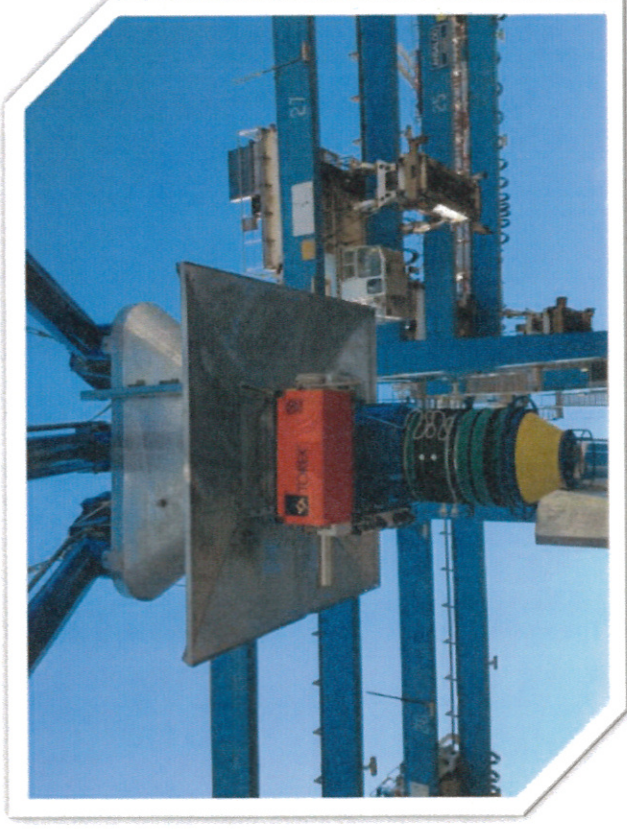
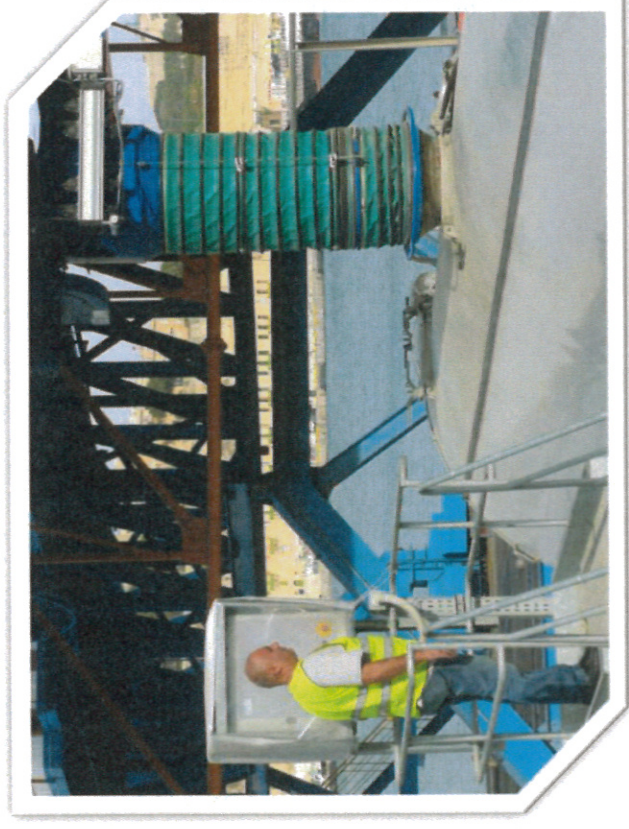
# Road tanker loading bellows

- Bellows are made of flexible neoprene coated with Hypalon which offers high resistance to atmospheric agents, abrasion and high temperature, thus making the loader highly durable.
- In built filtration system.
- Create a perfect seal with road cement bulk tanker.

Cement trucks are loaded by 'Torex Bellojet' dust free loading bellows. Both truck loading bellows are fitted with filtering cartridges having a filtering surface area of 10m<sup>2</sup>.

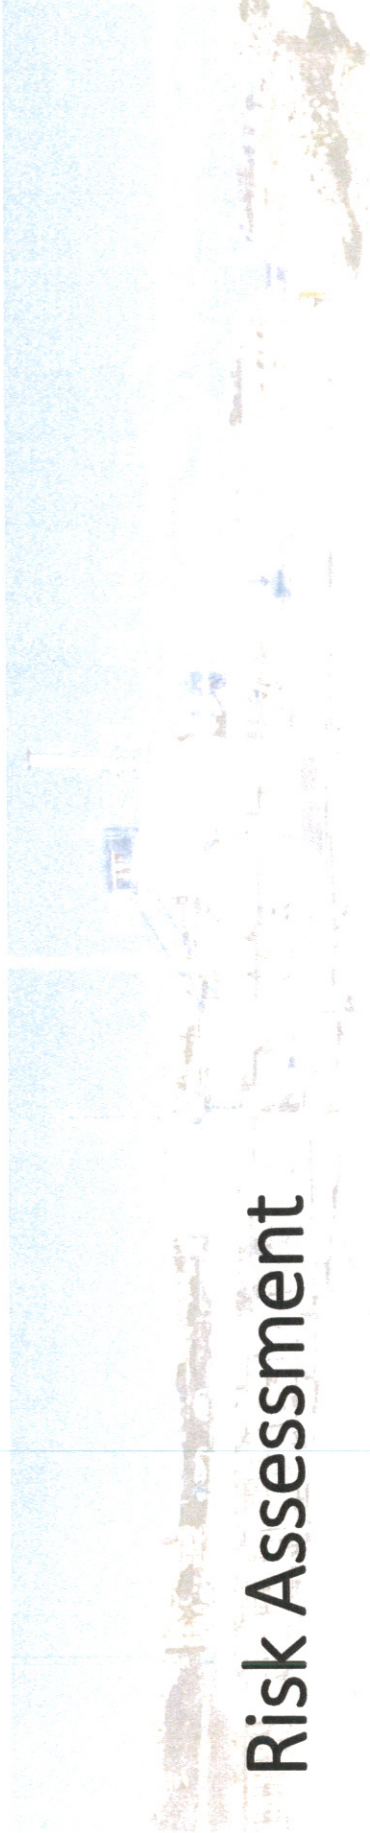
# Risk Assessment

Scope: Dust emissions

- FMEA (Failure Modes and Effects Analysis) approach
  - Operation
  - Part
  - Potential Failure Modes
  - Potential Failure Effects
  - Potential Causes
  - Current Controls
  - Recommended Actions
  - Risk Rating (RPN, i.e. Risk Priority Number)

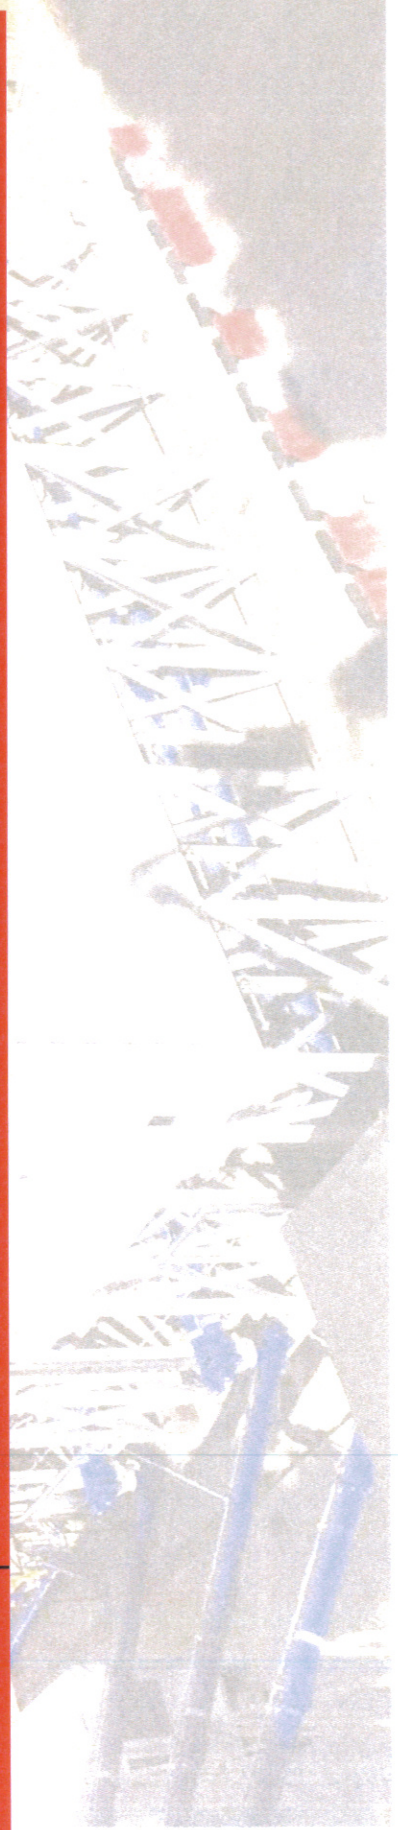
Table 4 - Risk Priority Number

RPN Range	Descriptor
1 - 40	Low Risk - Ensure that all control measures installed are subject to a strict maintenance regime and that they are checked prior to operation.
41 - 80	Medium Risk - Ensure that all control measures installed are subject to a strict maintenance regime and that they are checked prior to operation. Seriously consider taking additional measures to lower the risk to low.
81 - 120	High risk - Suspend operations and take remedial action to lower the risk level.

Item No	Operation	Part	Potential Failure Mode	Potential Failure Effect	Potential Causes	Reference Images (page 3)	Severity	Current Control Measures	Occurrences	Detection	Risk Priority Number (RPN)
1	Discharging of cement from ship to storage silos	Storage Silos - steel panels, hopper and roof	Failure to contain cement within structures.	Dust emissions	Comston of silo material.  Panel joints pulled apart due to external impact.  Failure of silo supporting structure due to excessive filling of silos, consequently overloading them.	1  2  3, 4	2  4  4	- New plant and protected with paint.  - Silos are constructed on concrete piths and away from main traffic routes. - A secure fence is installed around the silo perimeter. - Area is supervised.  - FRESH level indicates uniformly distributed within the silos which automatically raise an alarm in the event of overflowing during ship unloading. - Filling is carried out in direct communication with the ship. - Storage facility allows for full visibility of silo contents and their distribution. Location of discharge is controlled by plant operators.	3  2	2  1	12  8

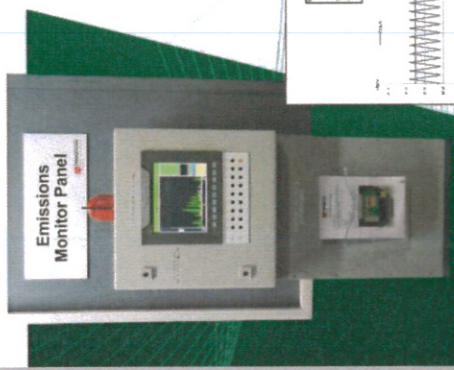
# A Continuous Emissions Monitoring System was installed

The system utilises EMS4 AC Coupled™, biocentric technology, employing a dual-task-recurrence PLC electronics housing with inlets at sensing element. As particles travel through the process they develop a charge, which is transferred into the sensing element. The resulting current is amplified, filtered, rectified and further filtered before being sent to the AC component. This gives a linear representation of the concentration in the sensing element. The sensing element is housed in a stainless steel enclosure, which is protected by an aluminium mesh. The AC signal is substantially amplified by an amplifier, which is then sent to the process parameter, which includes the build-up of process dust on the sensing element. The EMS4 totally filters out 50 Hz and 60 Hz frequencies related to the mains supply. The EMS4 linear representation of concentration has been validated by independent laboratories and has also been tested and certified for measuring dust emissions according to the UK Environment Agency's 'MCPERT' standard.

Each head is a self-contained monitoring unit with a 1" BSPP male thread, allowing connection to a dust-mounted 1" diameter stainless steel probe. The probe is made of stainless steel and has a simple electrical connection which includes 12V DC power and the RS485 signal. All heads include internal selection of the MODBUS address and a gain setting used to optimise the measurement for the particular application. For very dirty applications a compressed air purge can be connected to minimise contamination at the base of the sensing element.

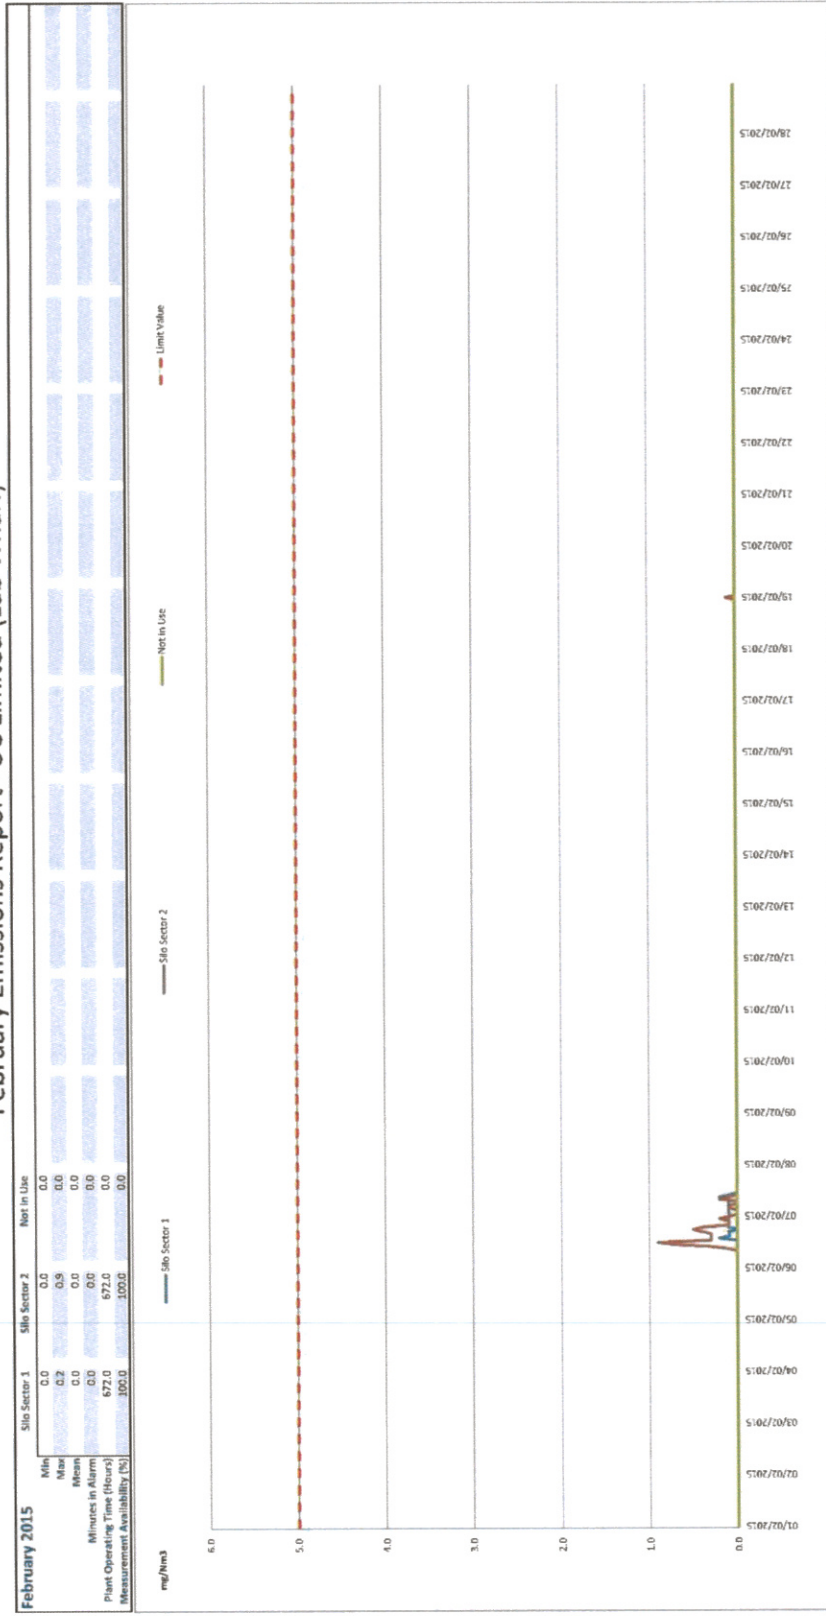
February Emissions Report - UC Limited (Lab Wharf)

# Emissions Reports are sent to MEPA on a monthly basis
