GHAWDEX – TEMPJI TAL-ĠGANTIJA - RAPPORT

STRUCTURAL SURVEY AT GGANTIJA TEMPLES, GOZO

CONTRACT CT2115/2009

STRUCTURAL ASSESSMENT REPORT

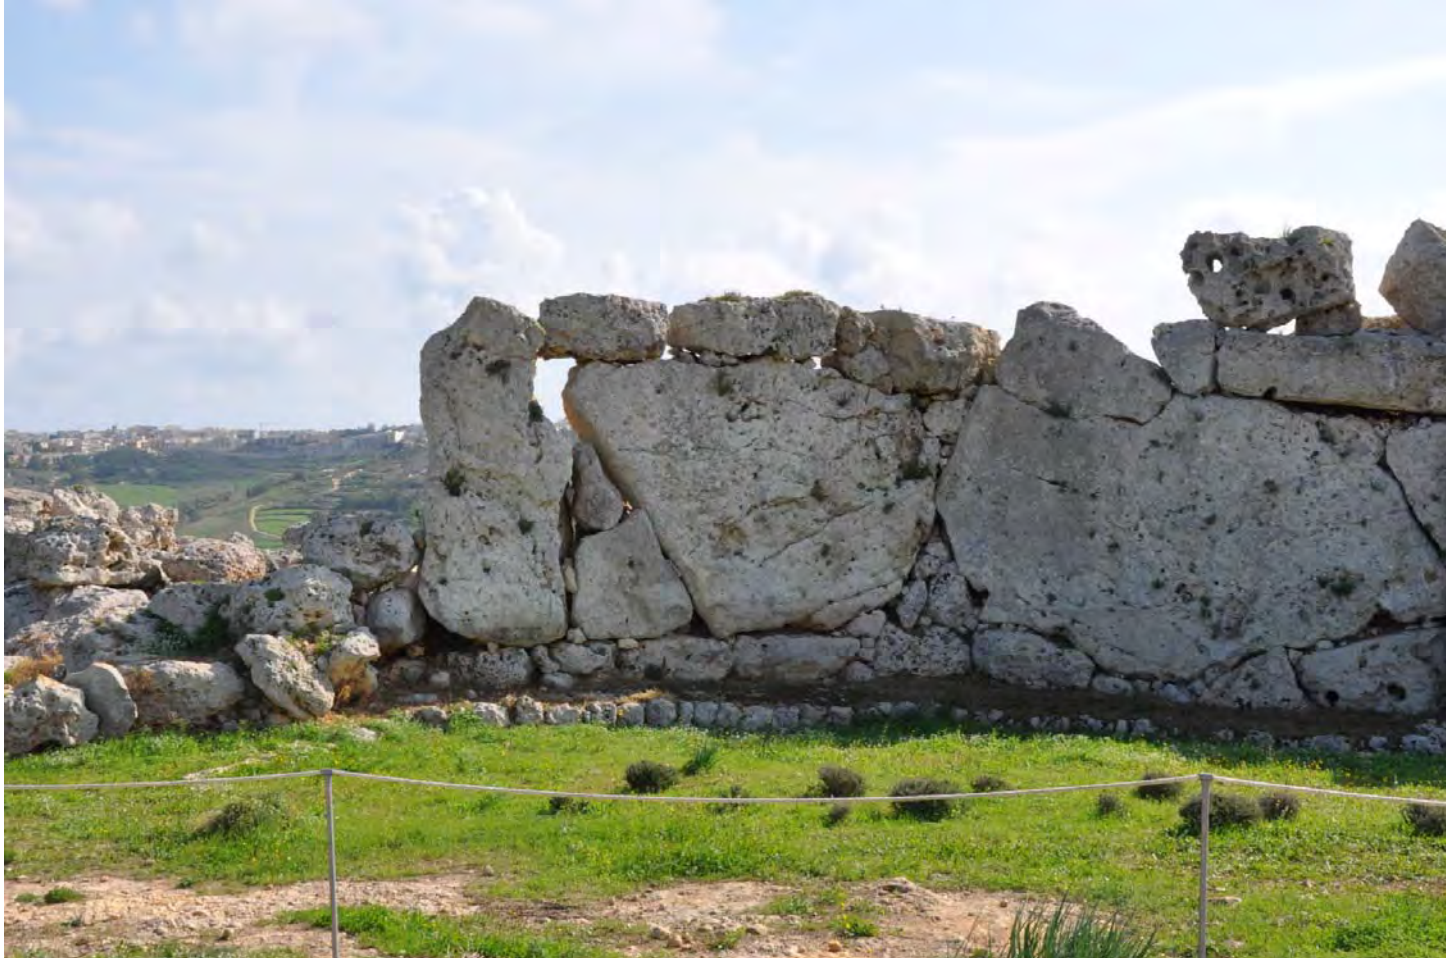
5. North-west external wall - detail

5. Detail of eastern end of the north-west external wall. Top megaliths are often not in contact with any adjacent megaliths, and contact with lower surfaces generally tenuous. This means that these megaliths are susceptible to actions normal to the plane of the wall.

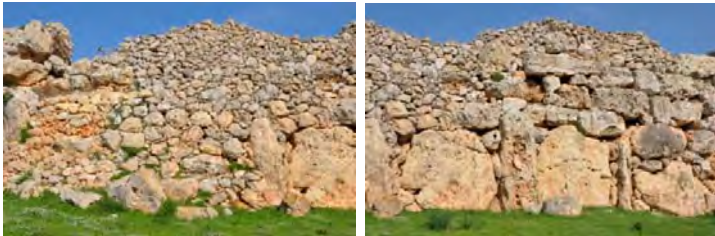
10. South-west elevation – previous collapse

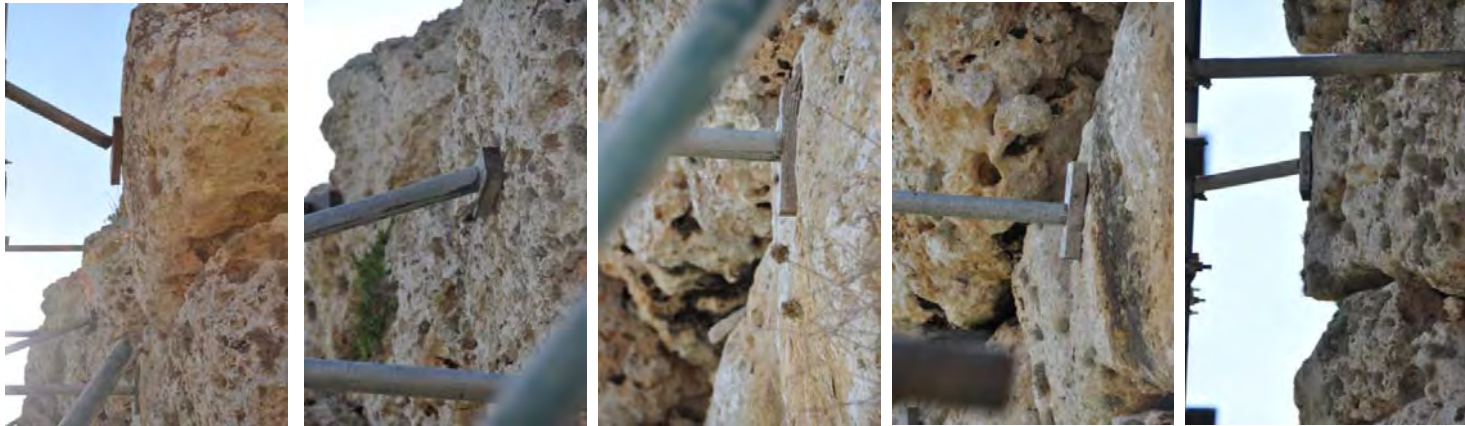
19. Propped south-east facade – close-up of contact between scaffolding and stones

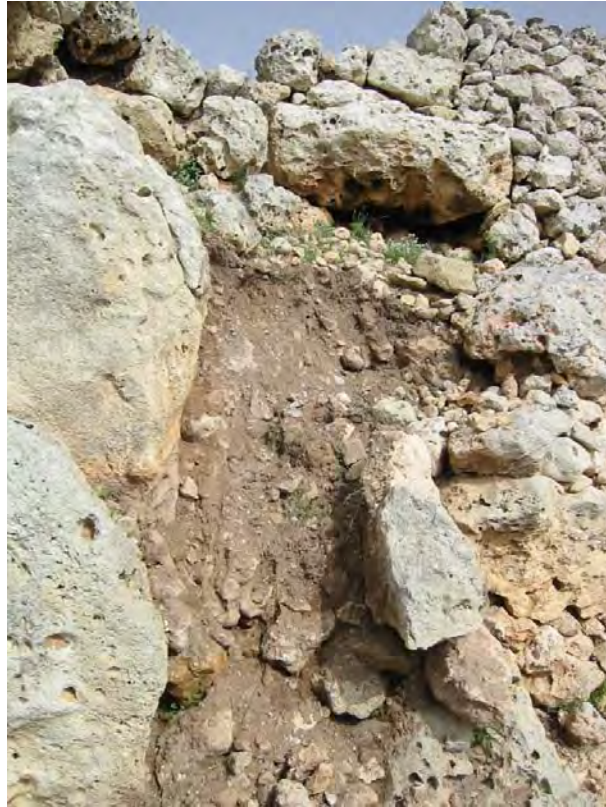
74. Detail of 2003 collapse

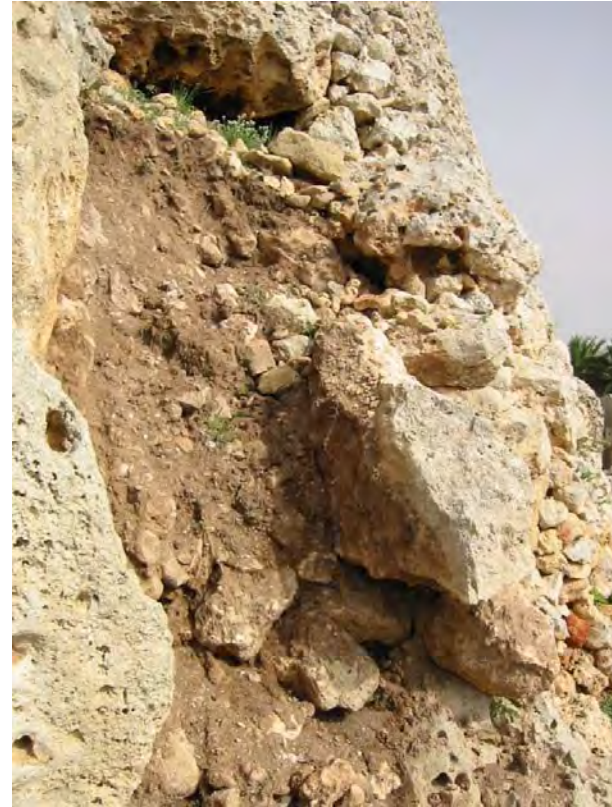
75. Detail of 2003 collapse
