GHAWDEX – TEMPJI TAL-ĠGANTIJA - RAPPORT

STRUCTURAL SURVEY AT GGANTIJA TEMPLES, GOZO

CONTRACT CT2115/2009

STRUCTURAL ASSESSMENT REPORT

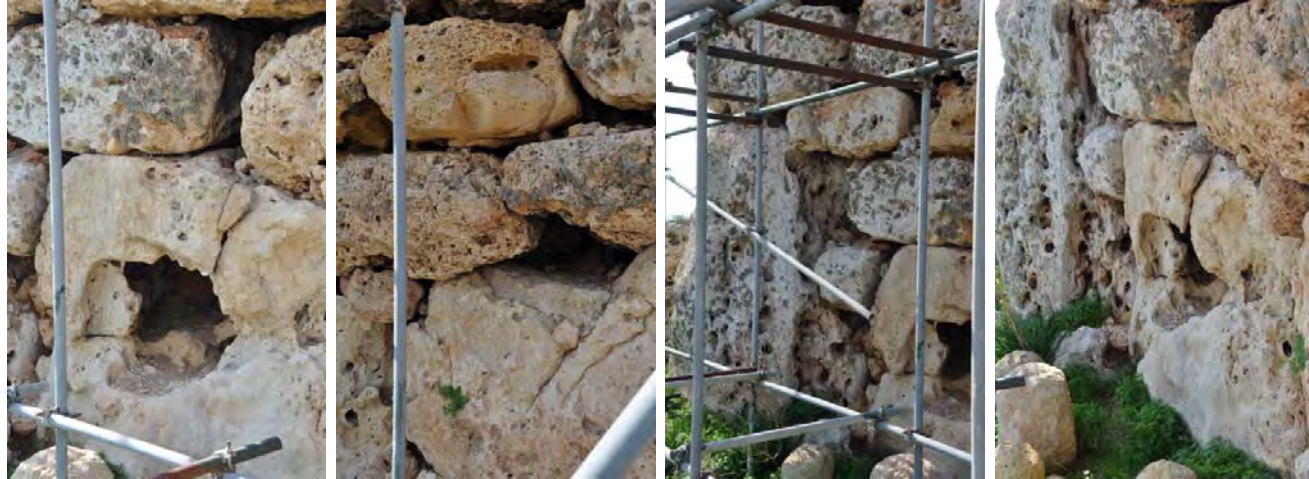
19. Propped south-east facade – close-up of contact between scaffolding and stones

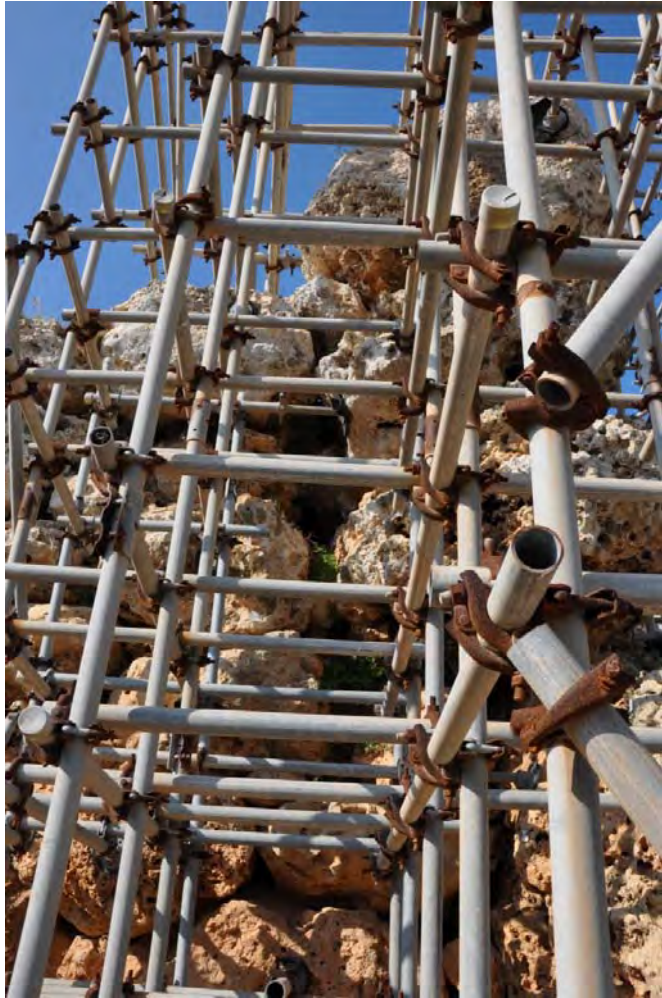
30 , 31. Detail of scaffolding – junction between apse 6 and 7 – discontinuity in masonry assembly

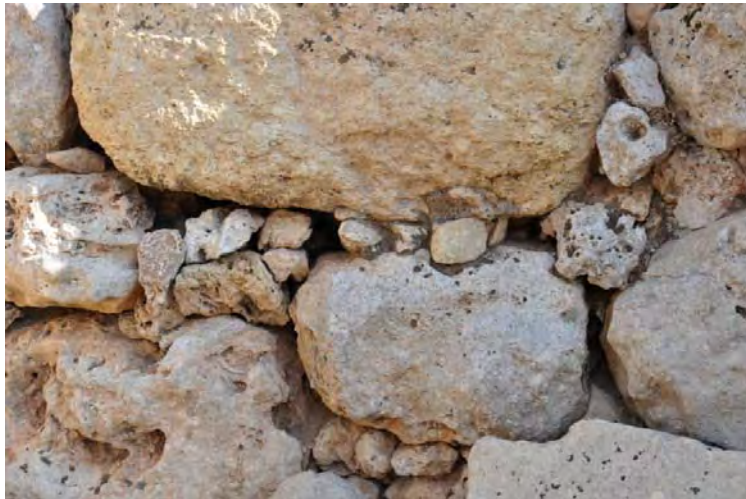
52.

The contact surfaces between megaliths are certainly non-uniform, but also very difficult to characterise. In addition, weathering of the contact surfaces, also exacerbated as a result of higher stresses present, produces an ever-changing situation of equilibrium. The same high stresses also result in damage (cracking) of the stones, especially the smaller stones wedged in between the larger ones, in order to lock them in place. This damage becomes more likely as the stones are exposed to weathering mechanisms, which affect the intrinsic cementation of the stone. When small pieces of stone are lost, the state of equilibrium changes, leading possibly to a new situation of contact stresses, or to a subsequent loss of other stones, or to a catastrophic collapse of the whole assemblage. It is impossible to model these mechanisms without detailed and accurate information about the stones, the contact surfaces, as well as the rate and type of weathering.

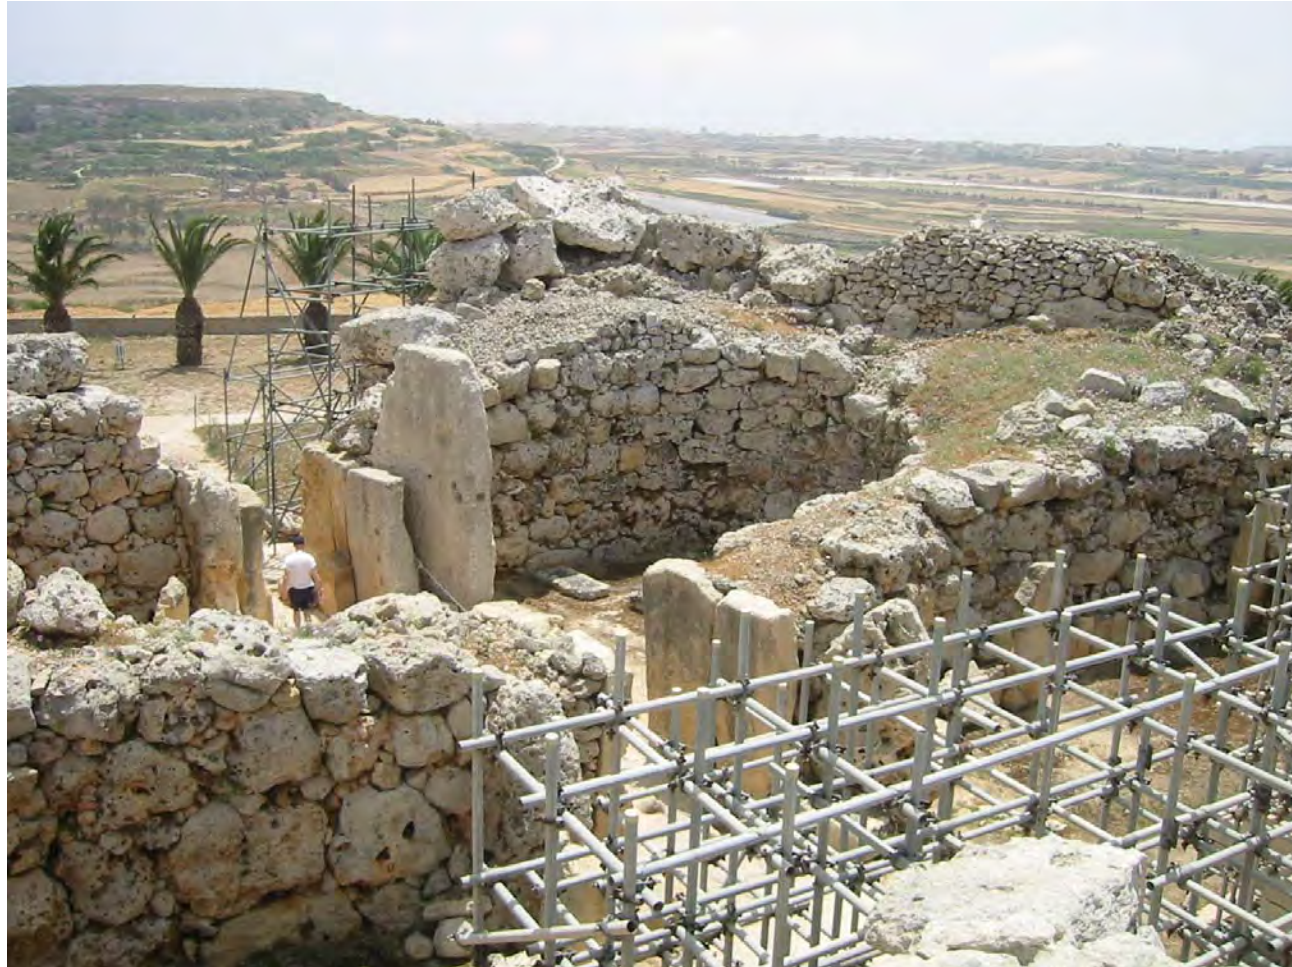
76. 2005 view of South Temple – rear view of South Facade

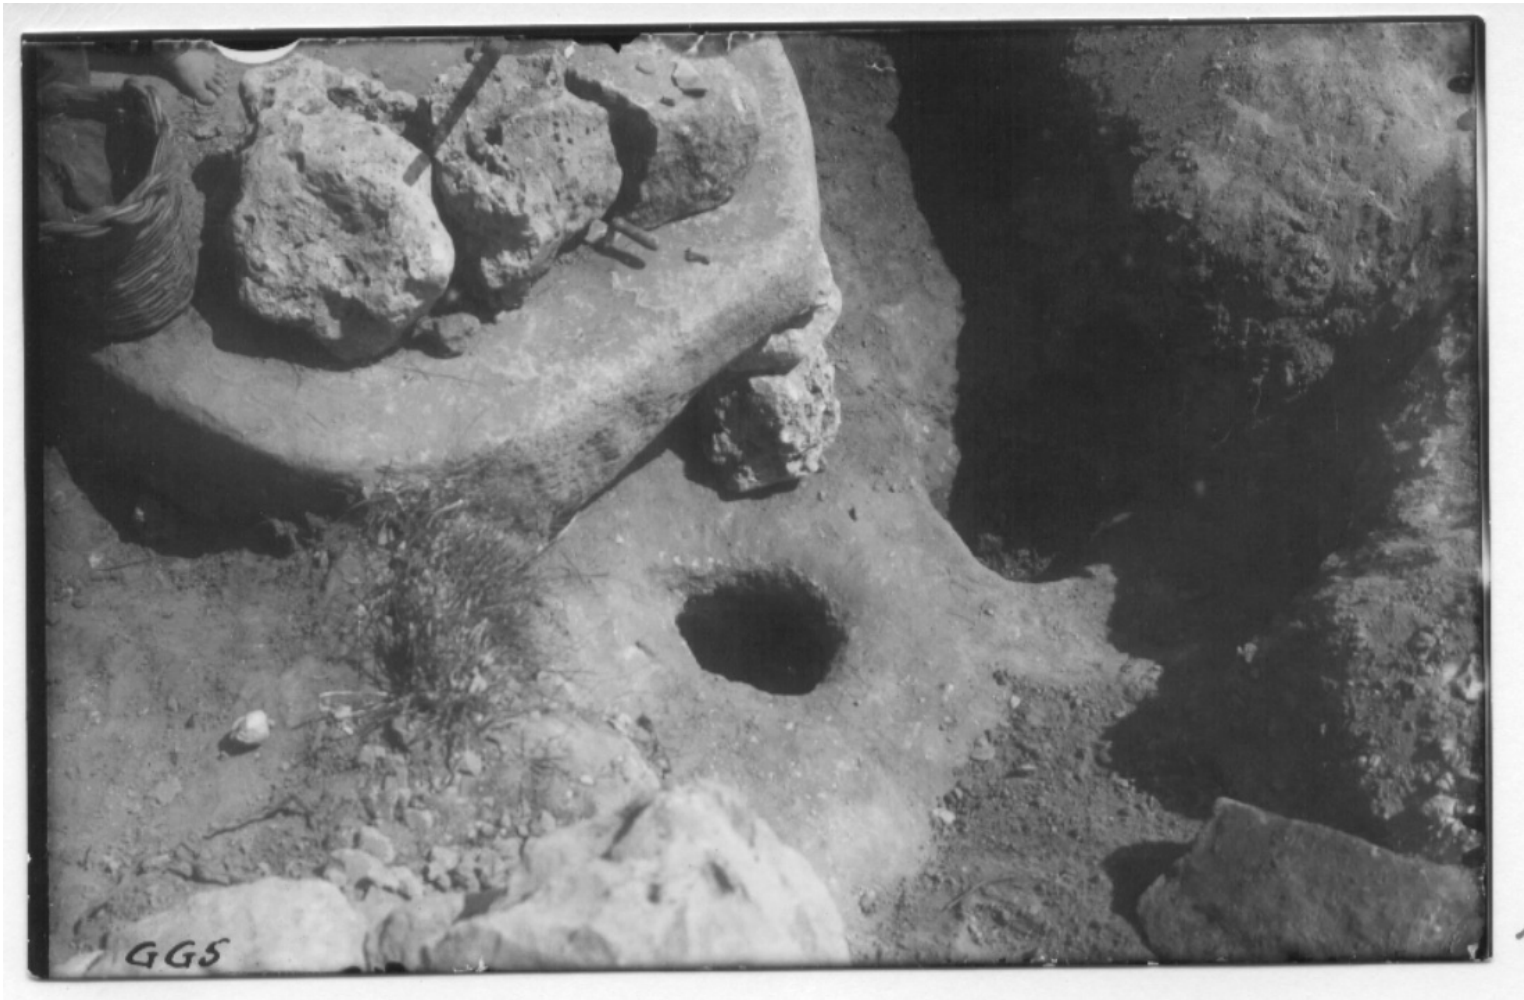
16. Historic Views 1933 – Entrance South Temple – Archives Heritage Malta

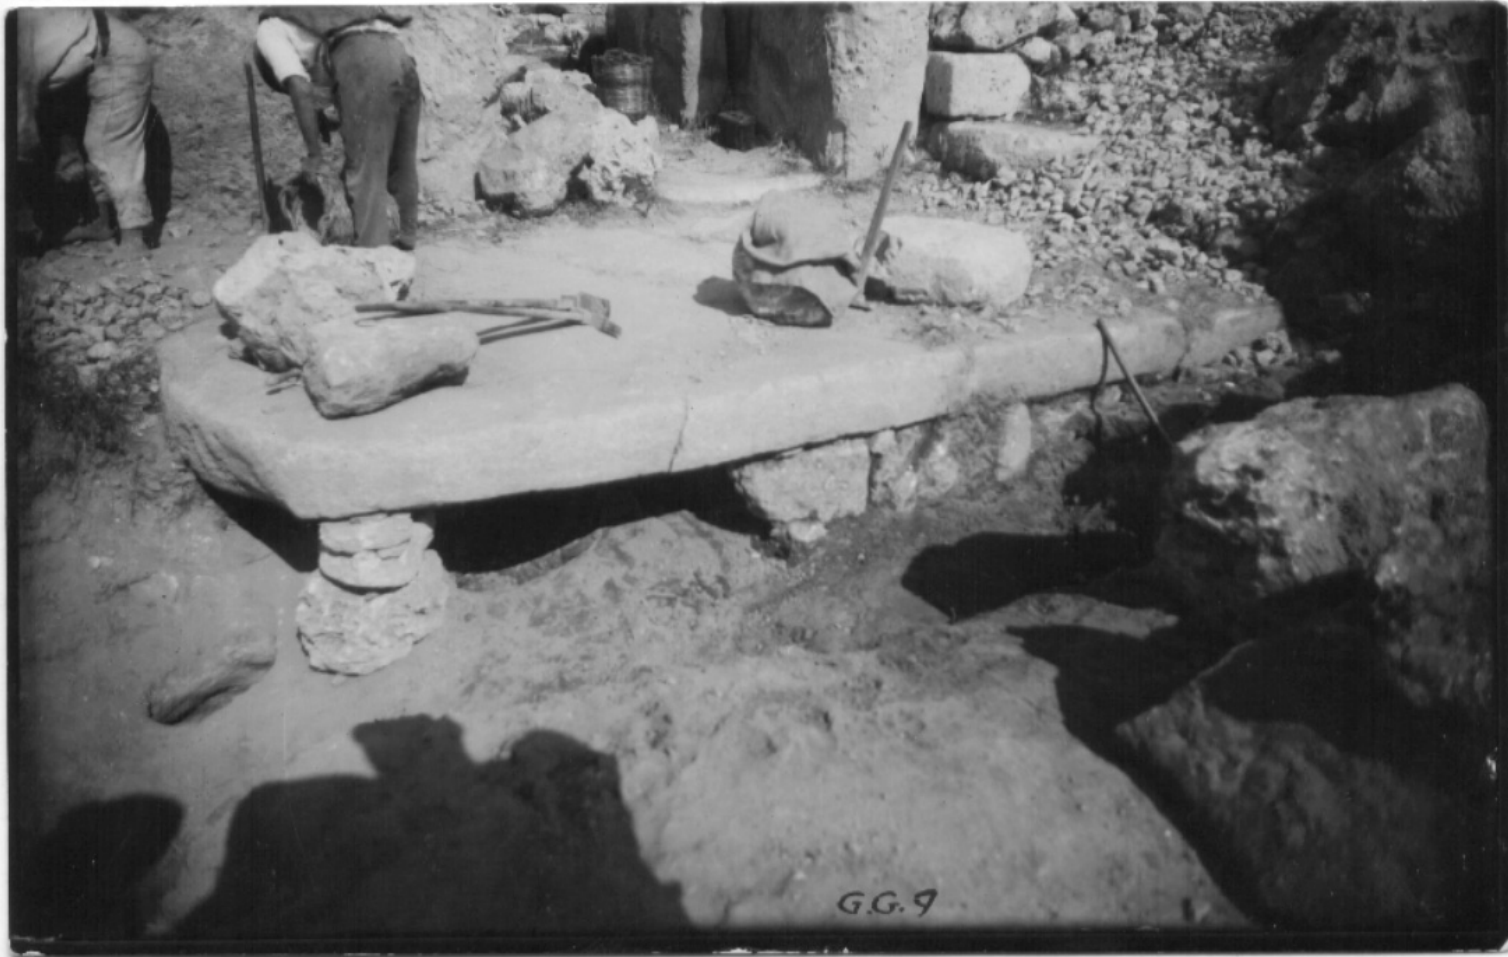
17. Historic Views 1933 – Entrance South Temple – Archives Heritage Malta

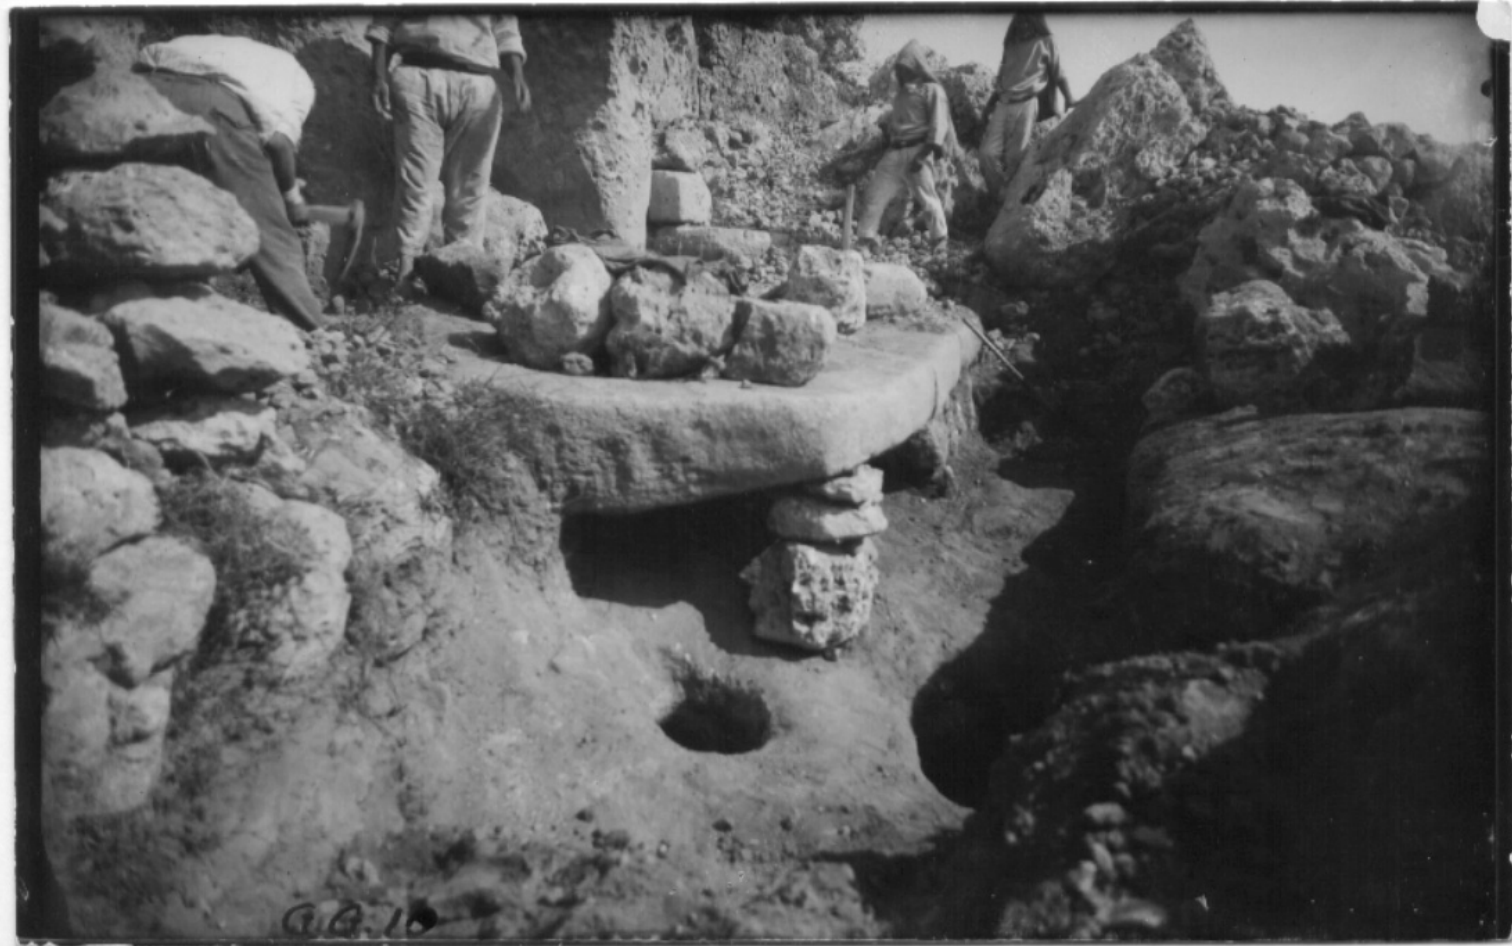
18. Historic Views 1933 – Entrance South Temple – Archives Heritage Malta

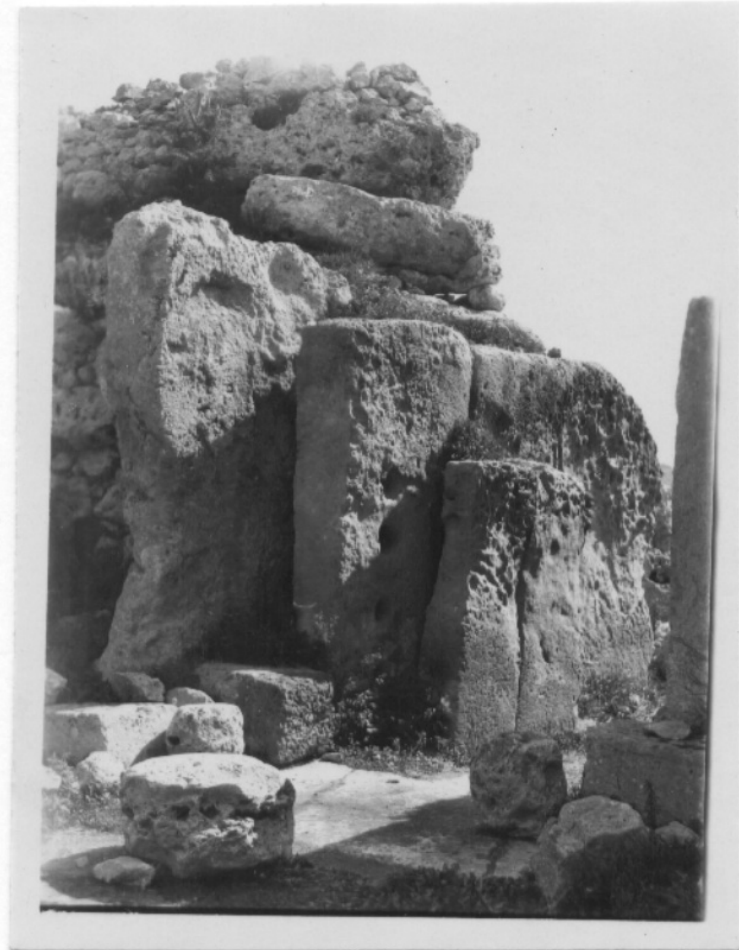
19. Historic Views – Entrance South Temple – Archives Heritage Malta

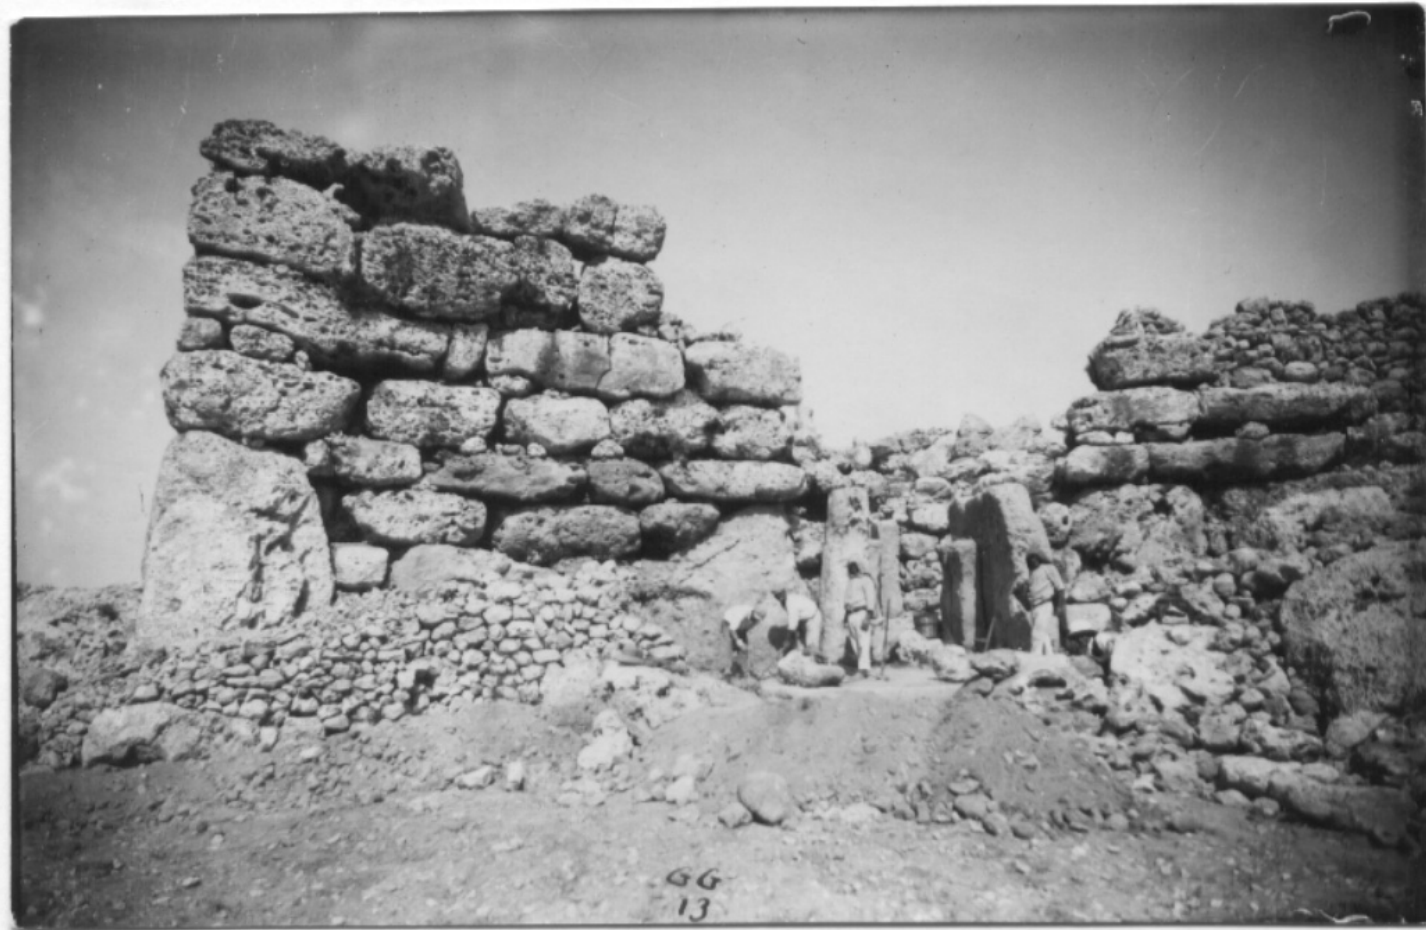
20. Historic Views (1933?) – Facade South Temple – Archives Heritage Malta

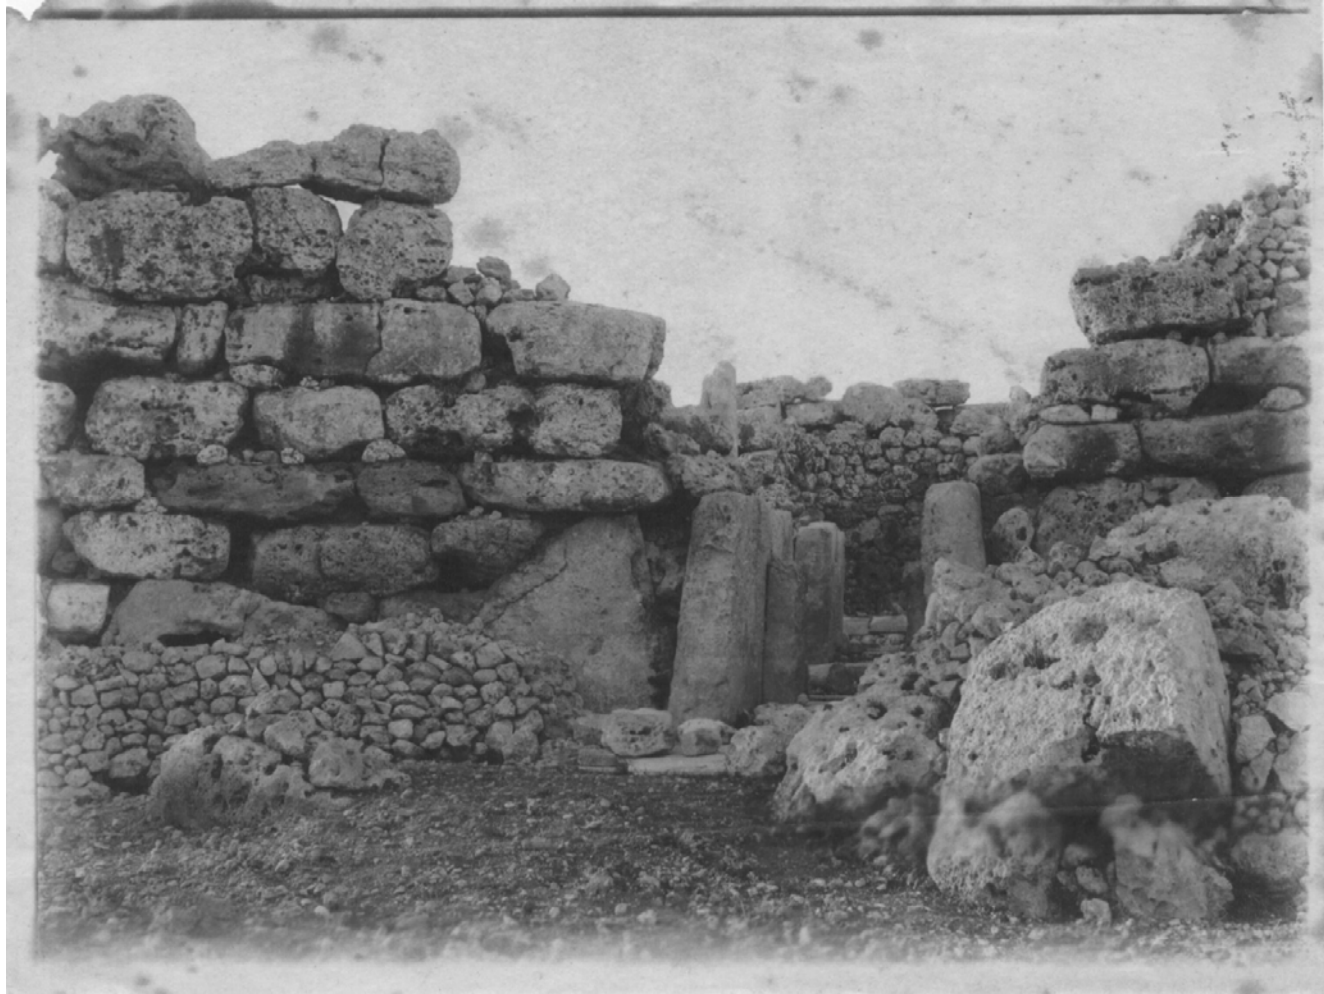
22. Historic Views – Facade South Temple – Archives Heritage Malta

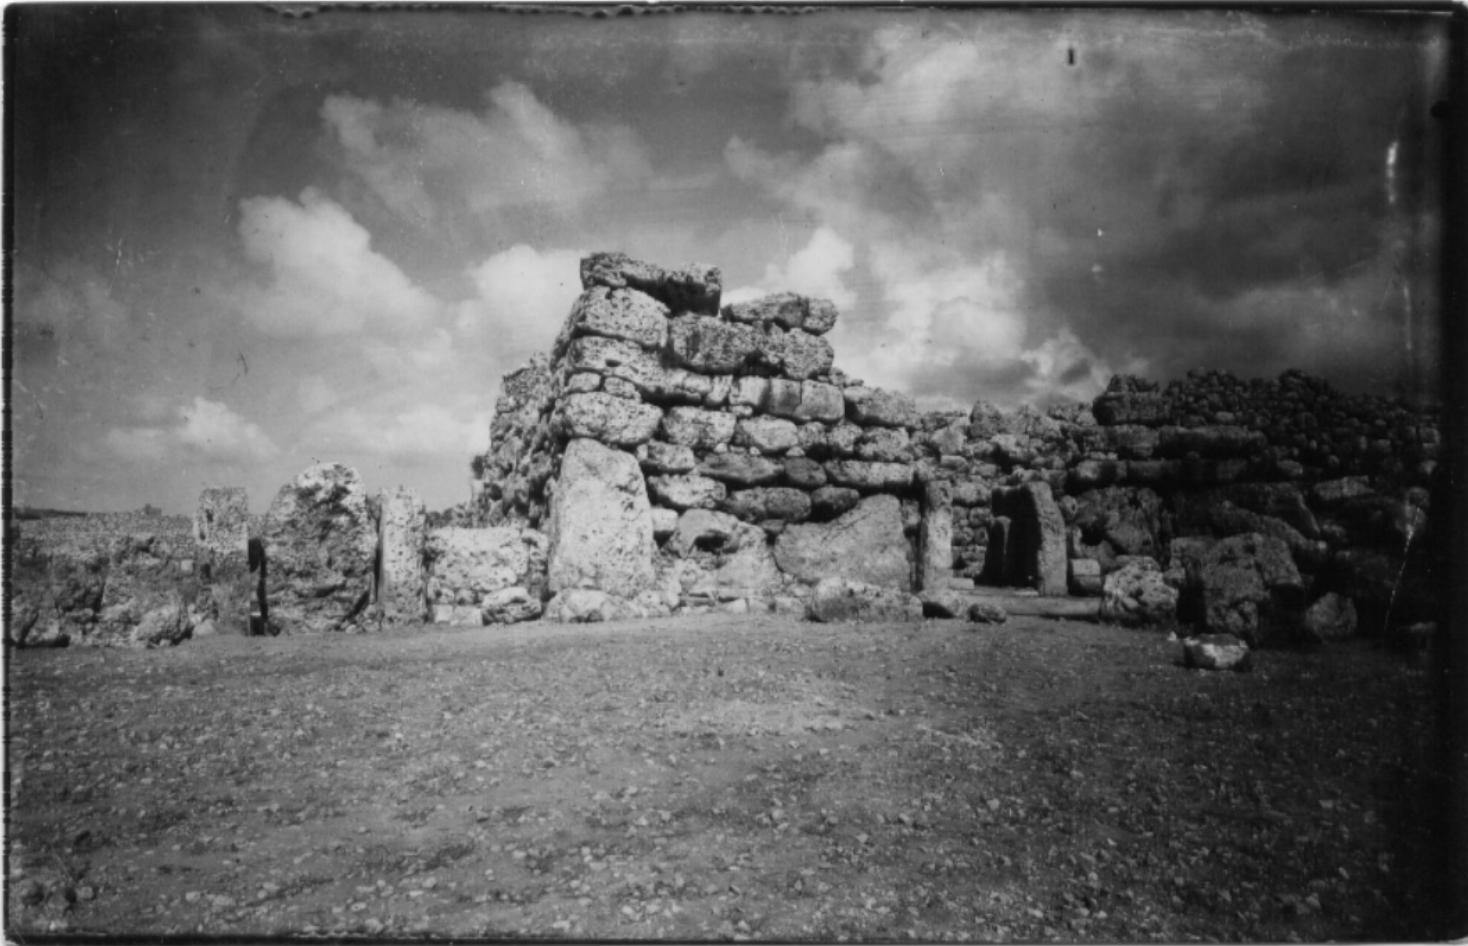
24. Historic Views 1936 – Facade South Temple – Archives Heritage Malta

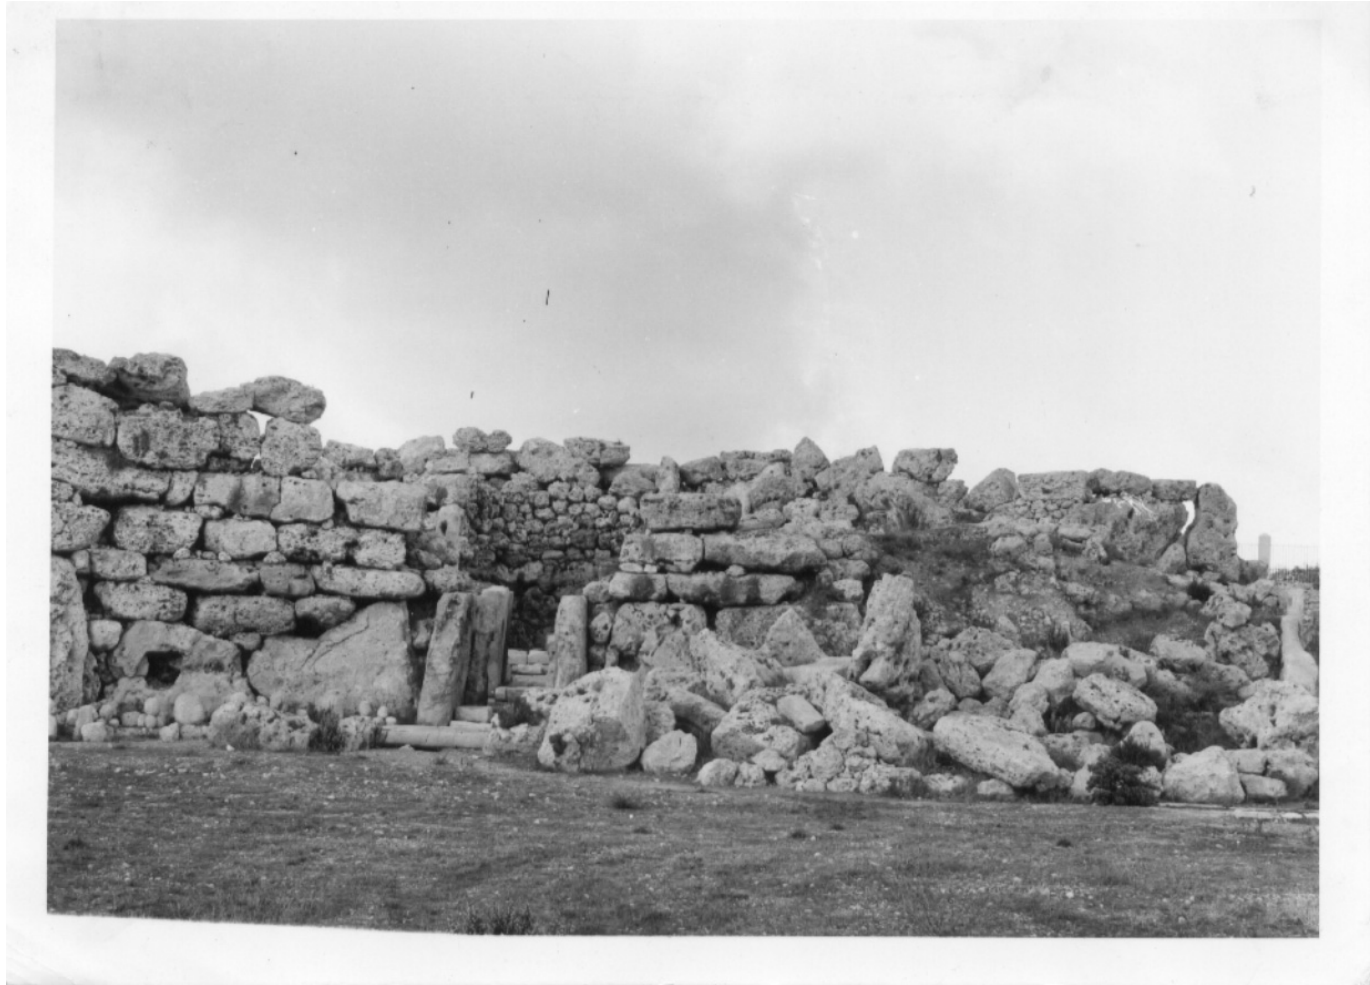
25. Historic Views – Facade South Temple (East End) – Archives Heritage Malta

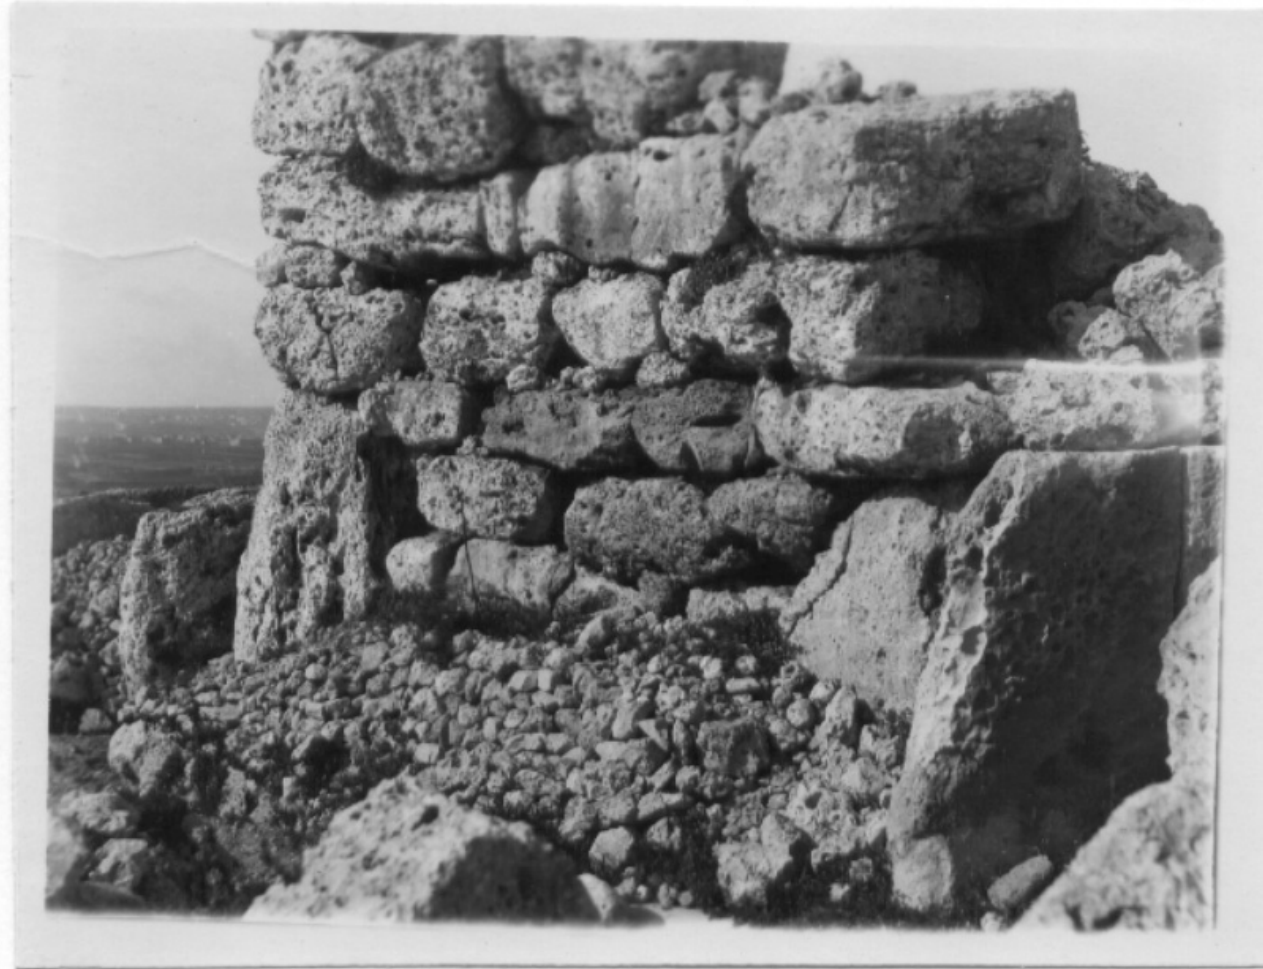
26. Historic Views – Facade South Temple – Archives Heritage Malta

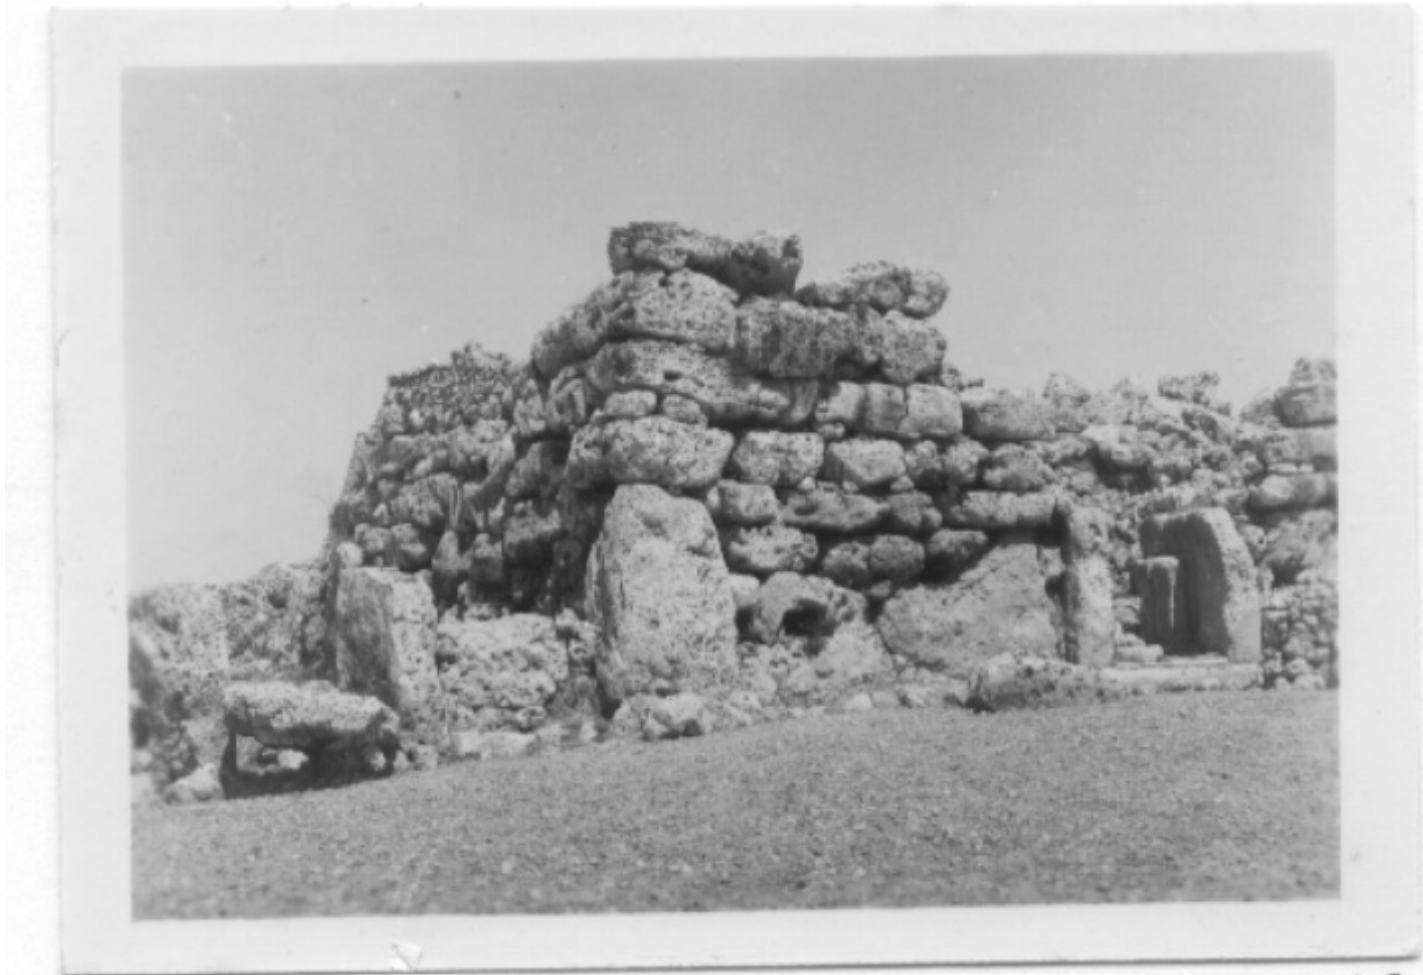
27. Historic Views – Facade South Temple – Archives Heritage Malta

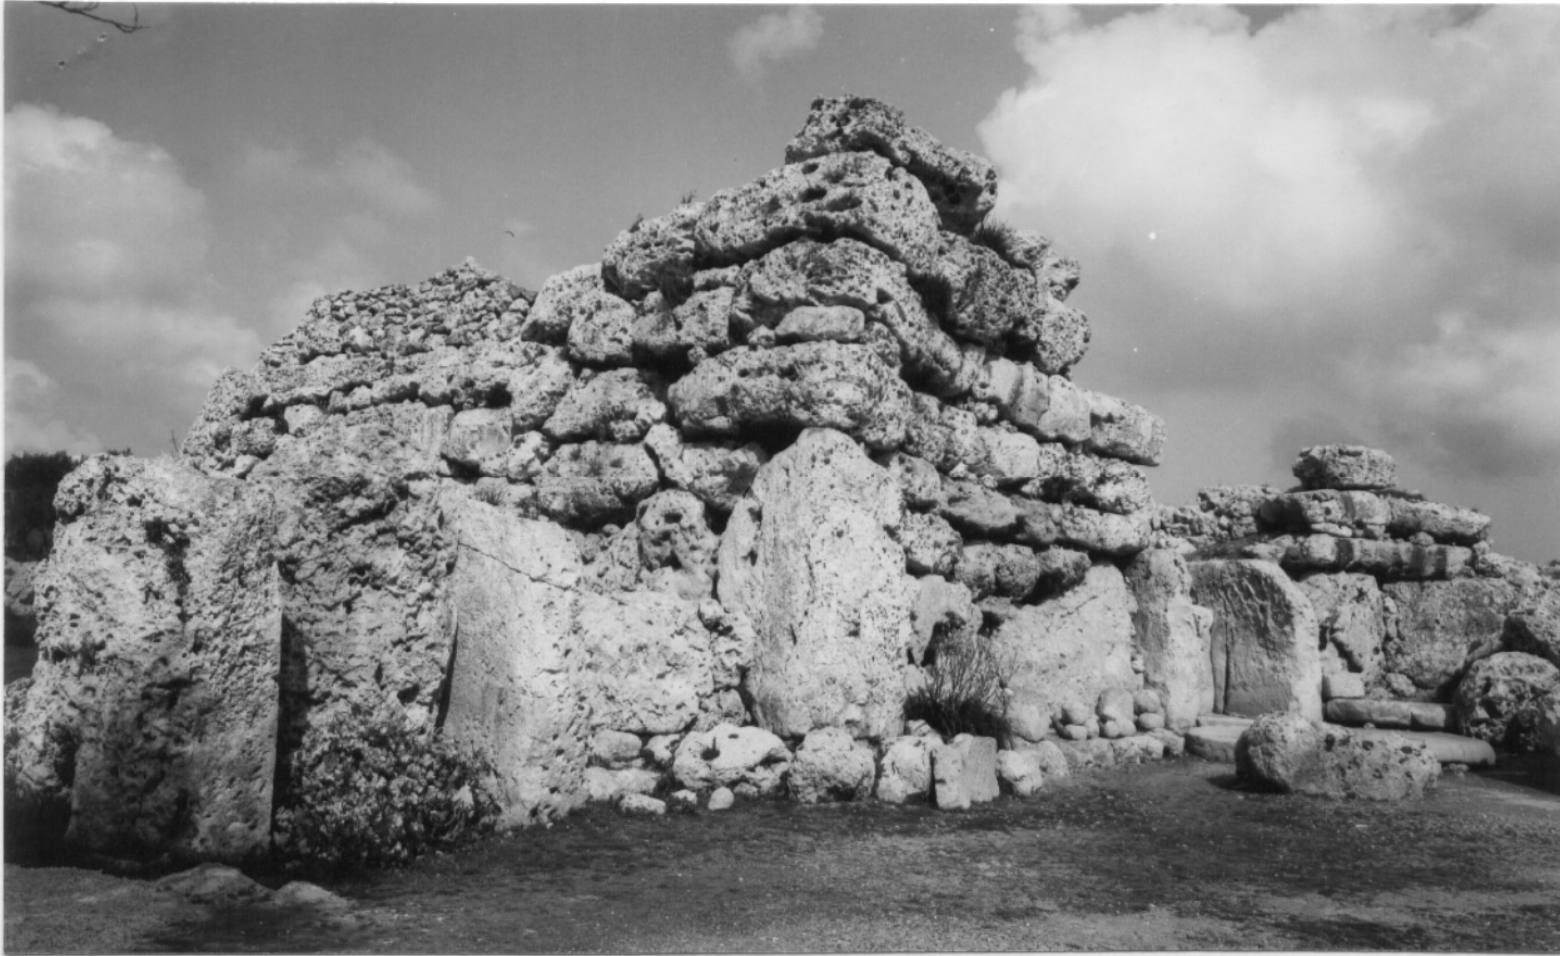
28. Historic Views – South View South Temple – Archives Heritage Malta

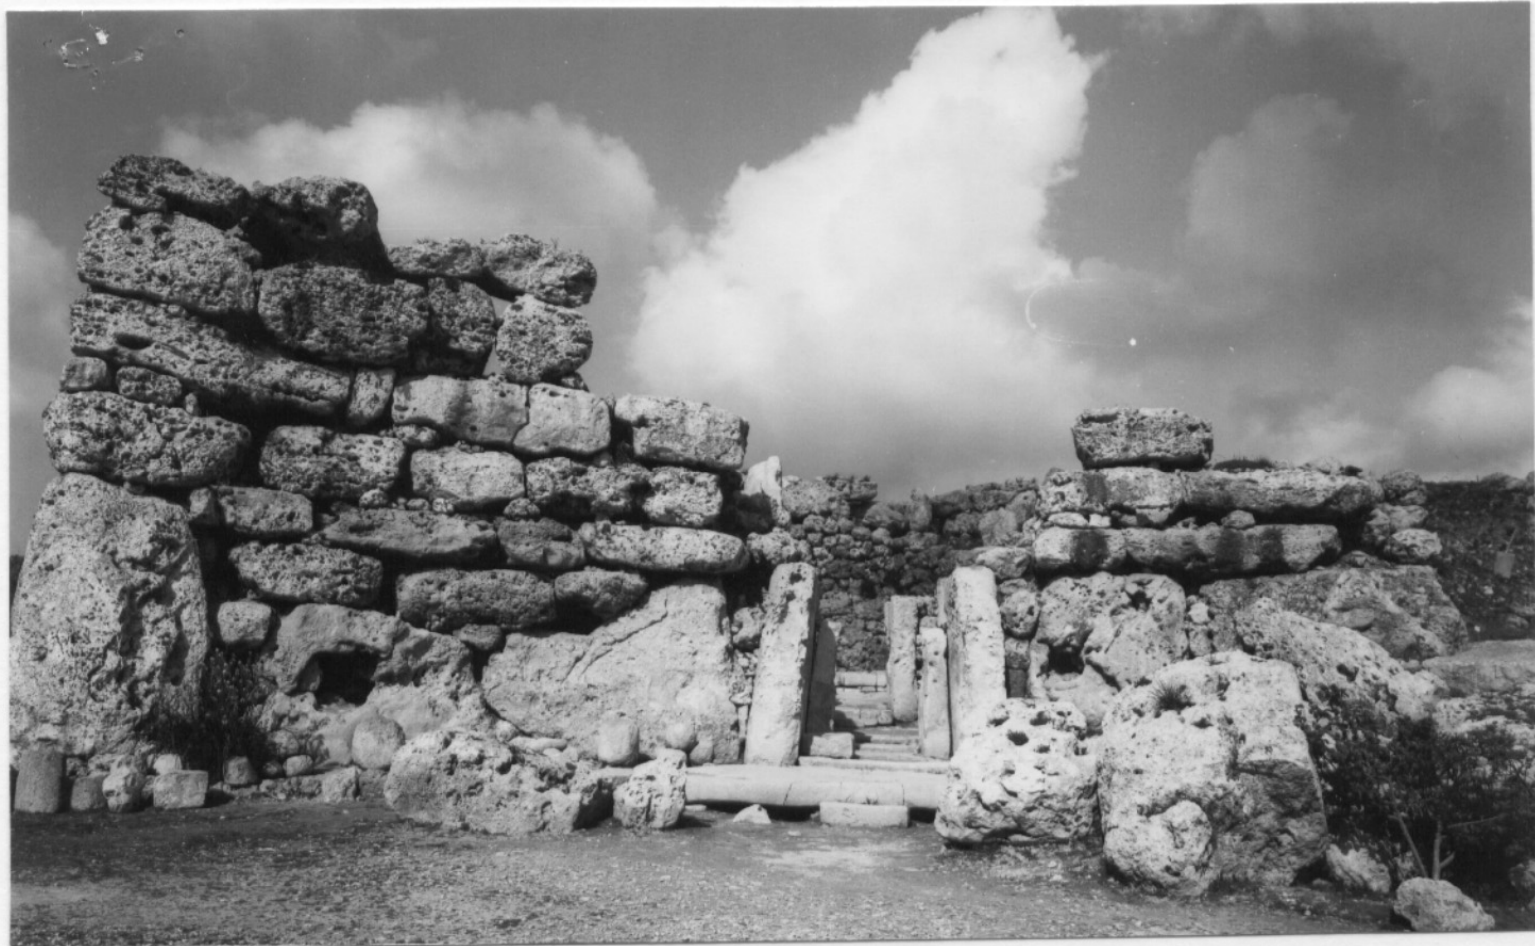
29. Historic Views (1960?) – South View South Temple – Archives Heritage Malta

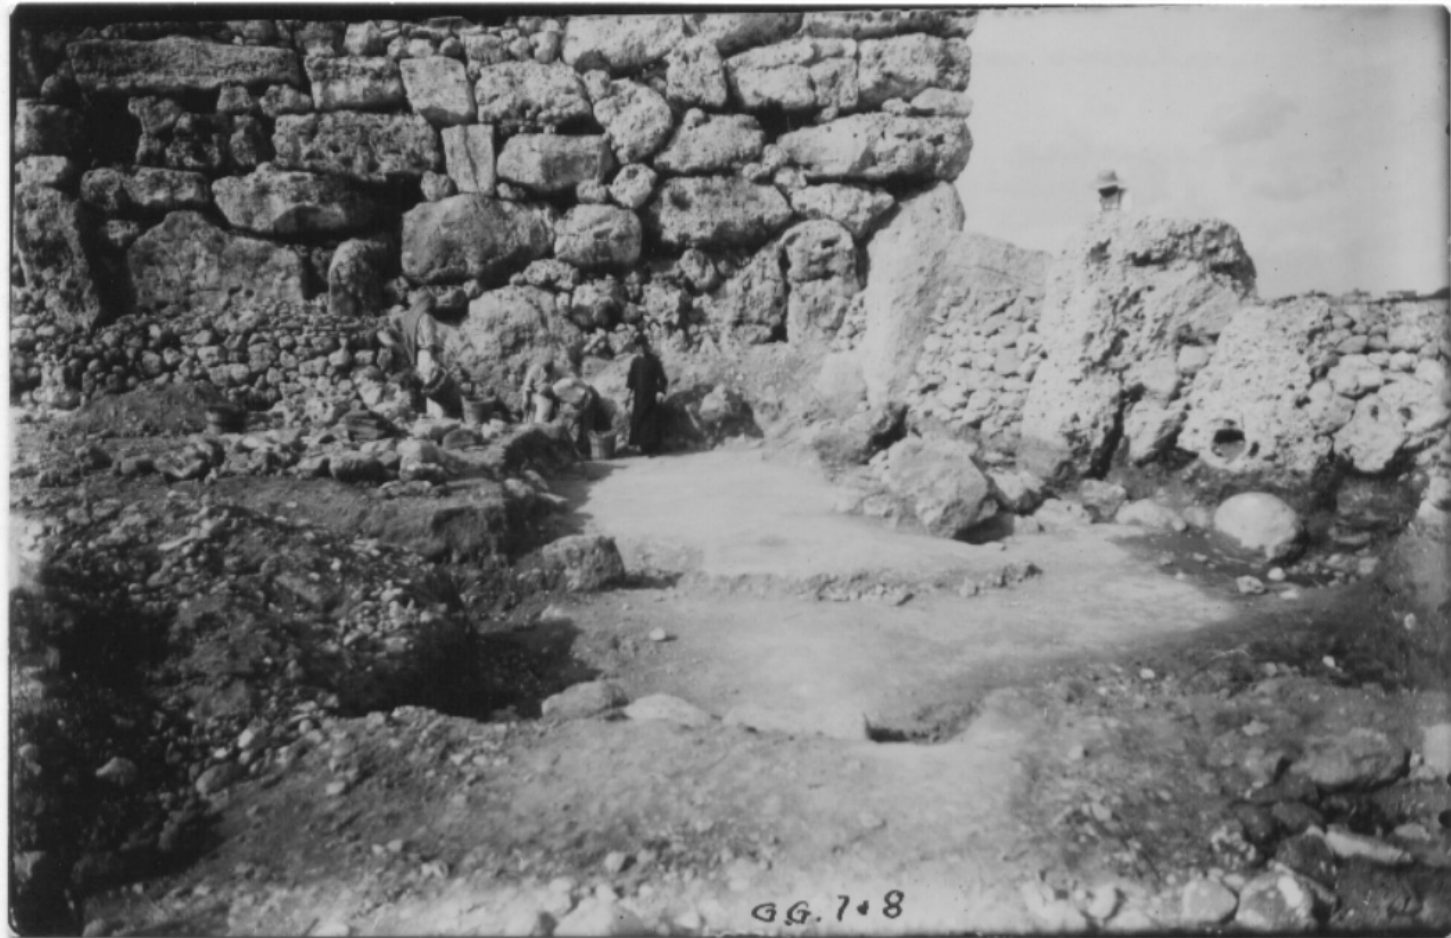
30. Historic Views (1933?) – South View – Archives Heritage Malta

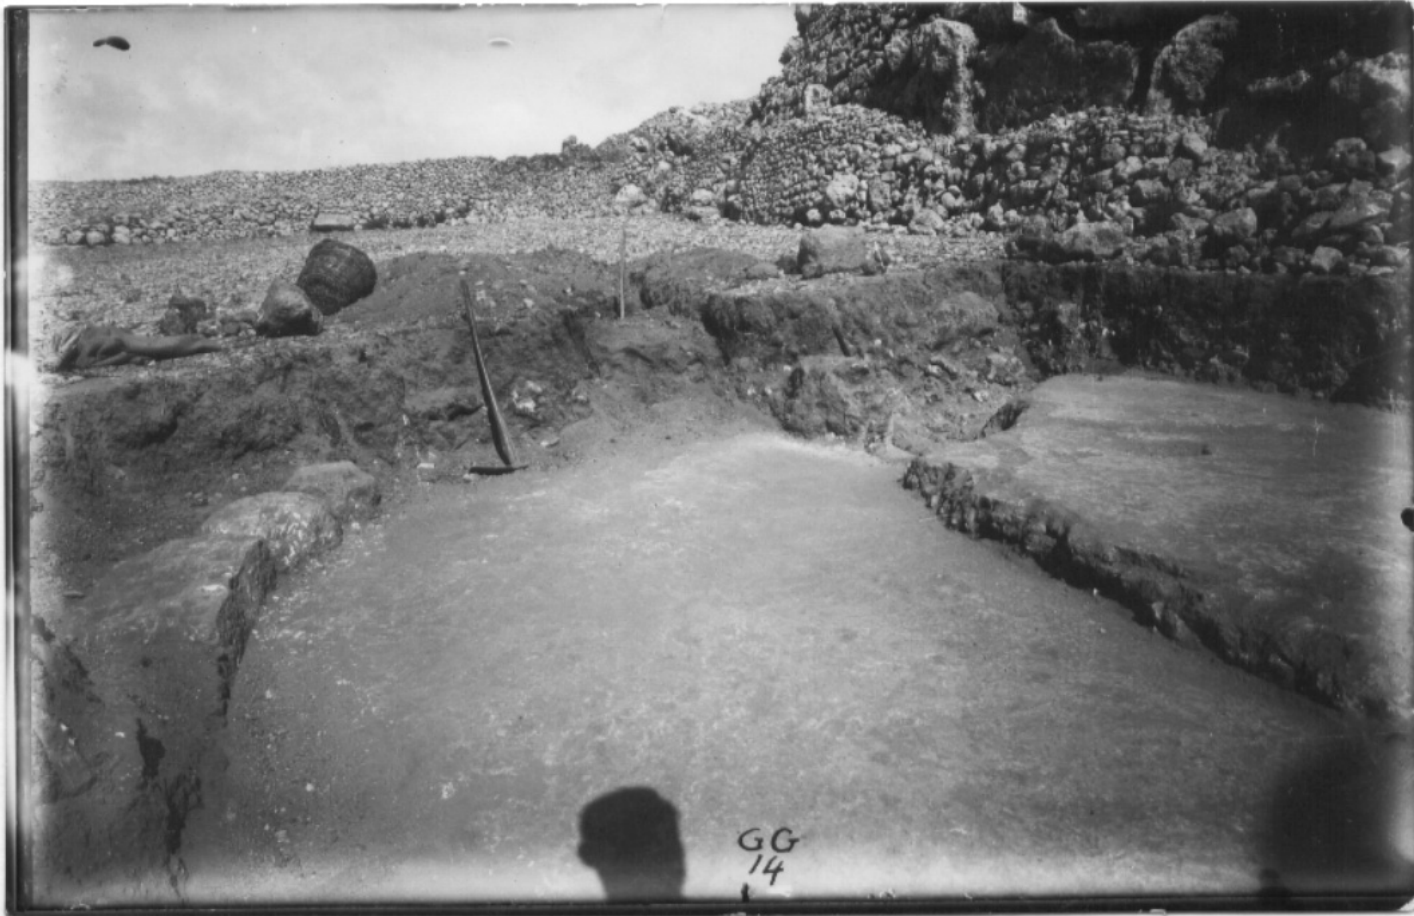
31. Historic Views (1933?) – South View – Archives Heritage Malta
